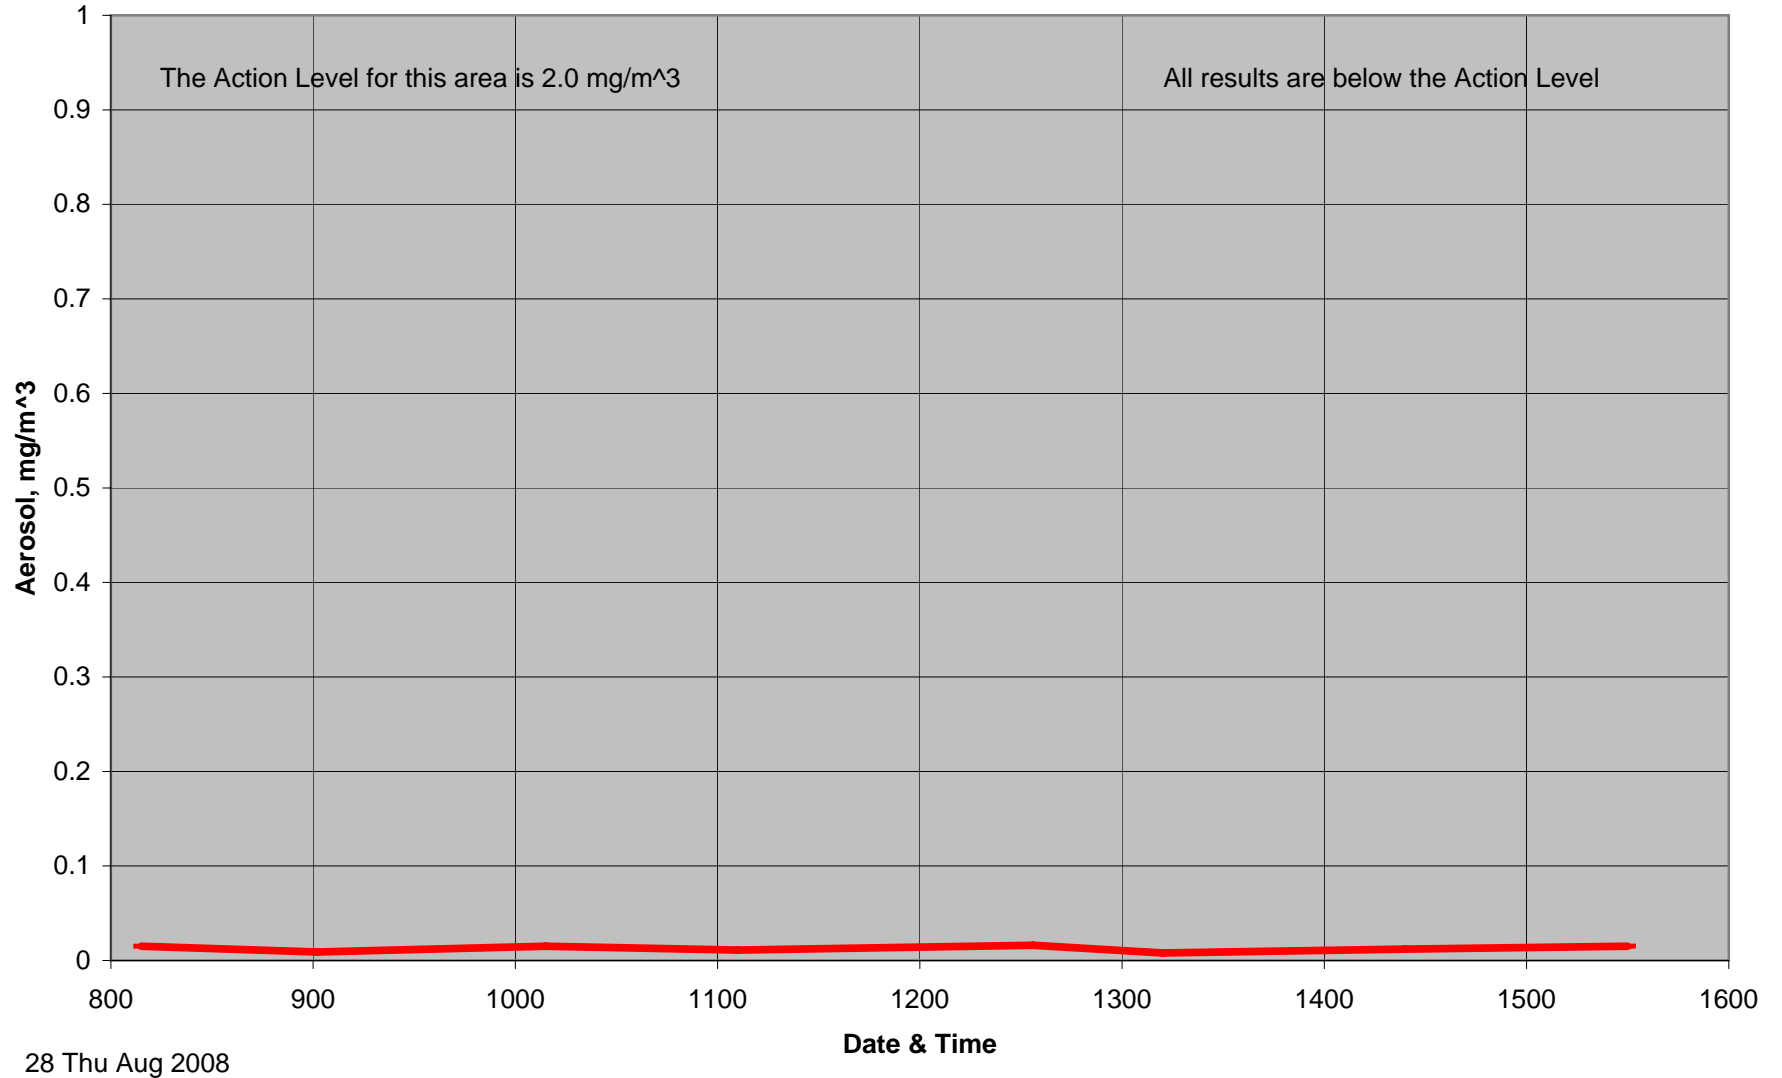
### Air Monitor 5

Southwest of Containment Area, Upwind of Site Activities

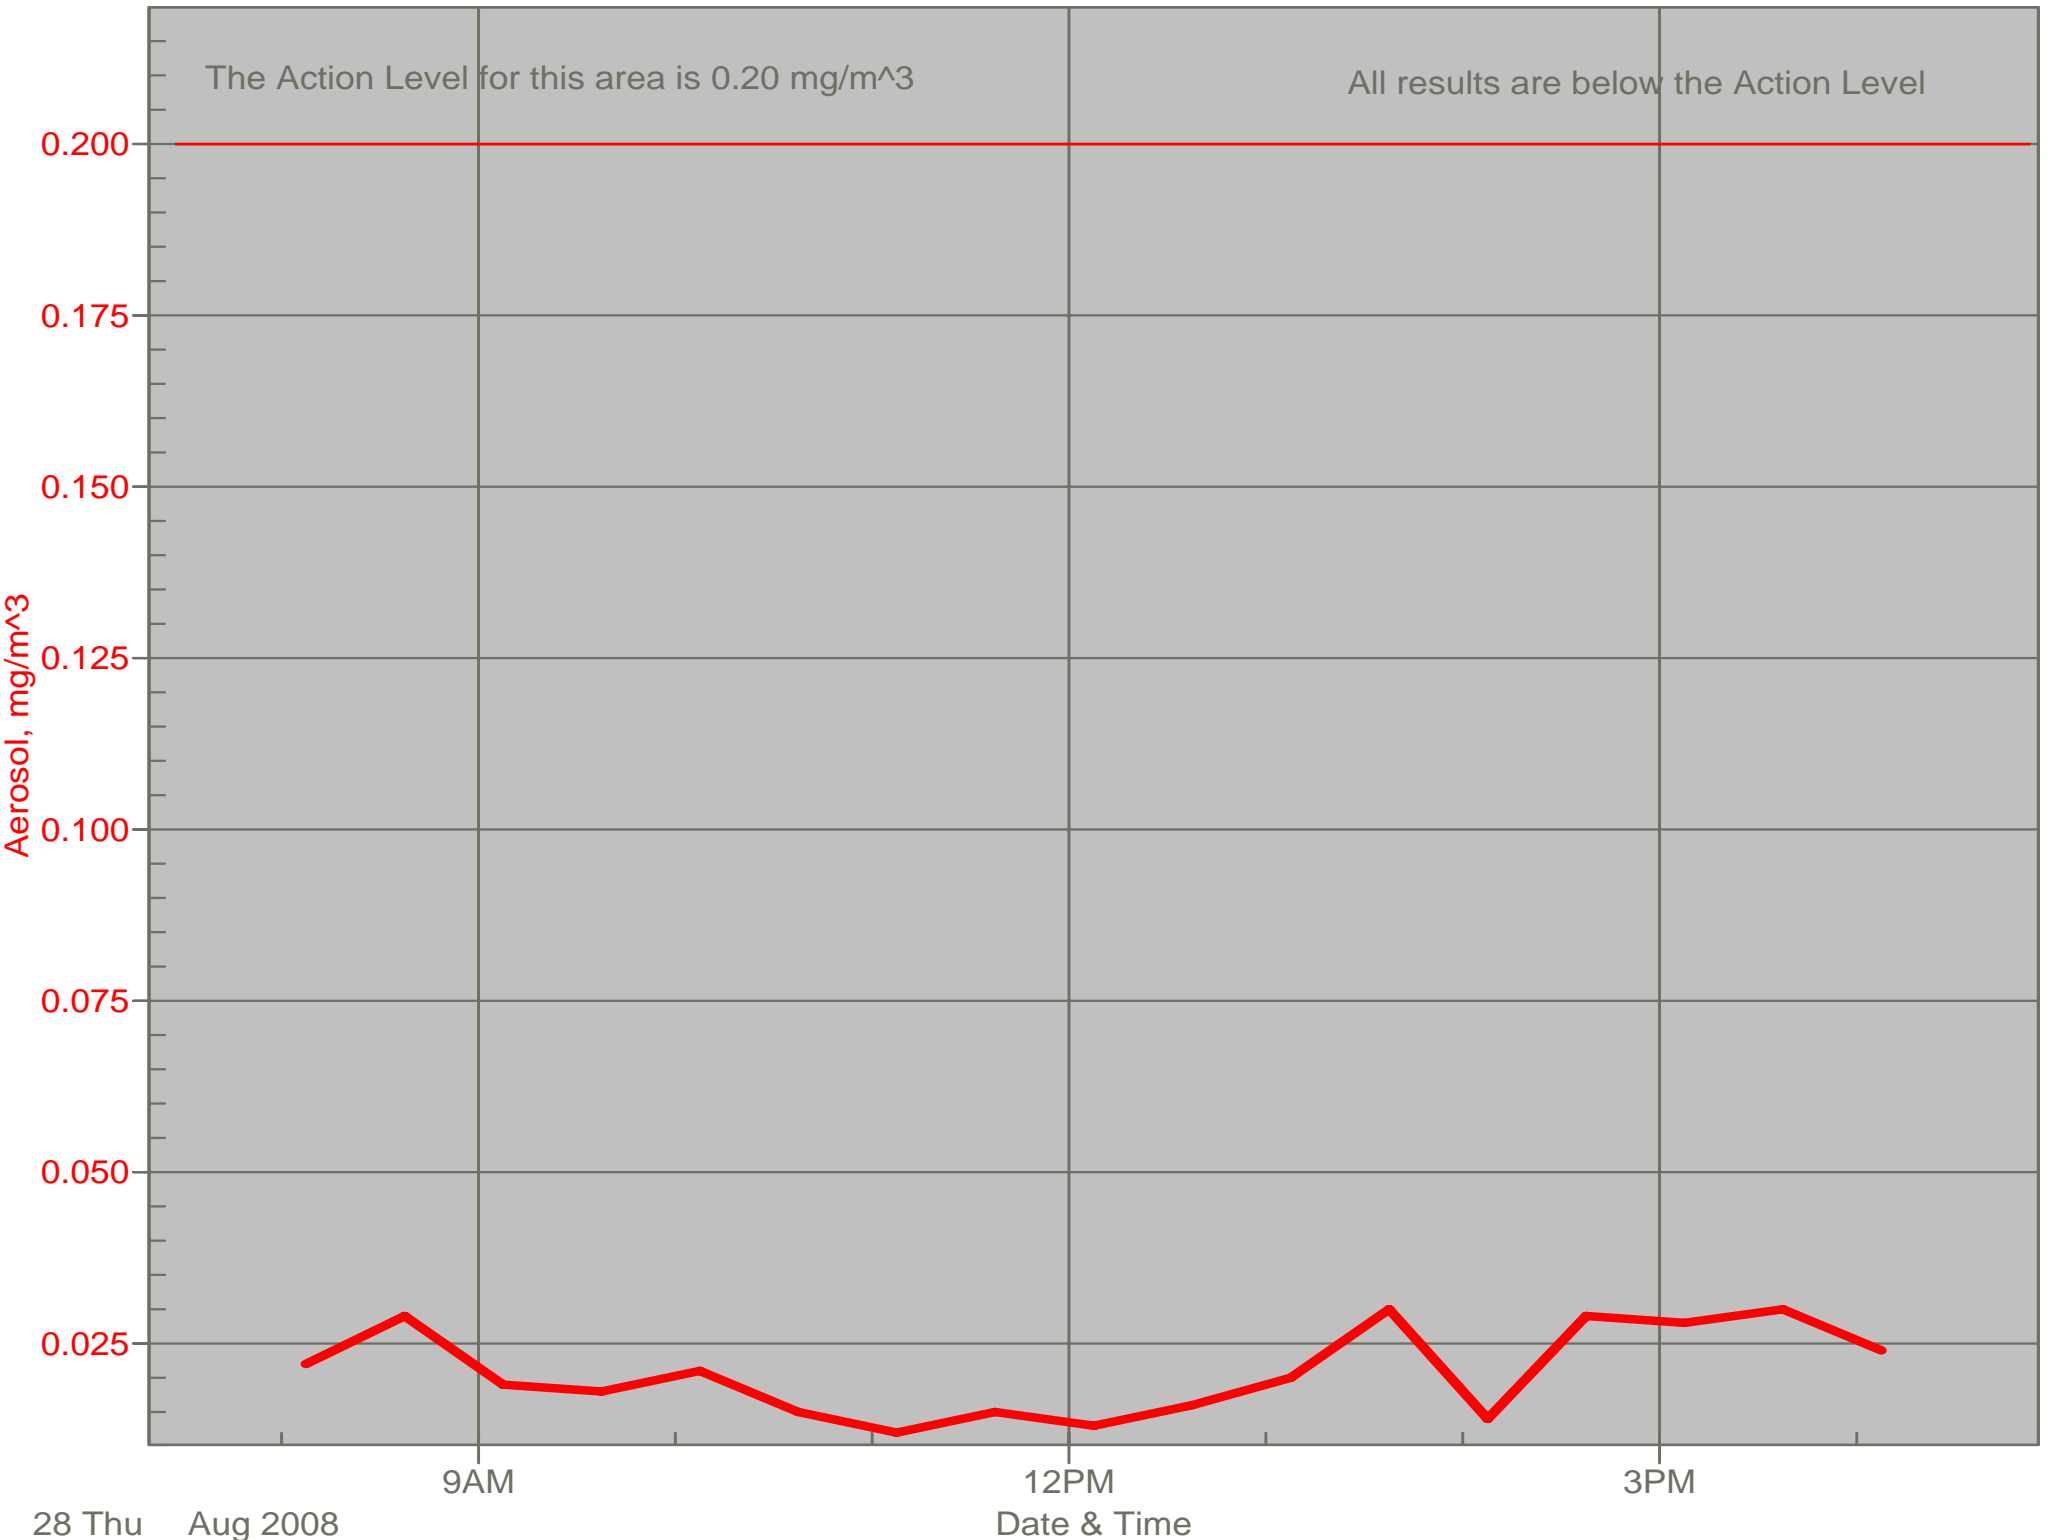
# Air Monitor 1

Southeast of Containment Area, Downwind of Material Placement

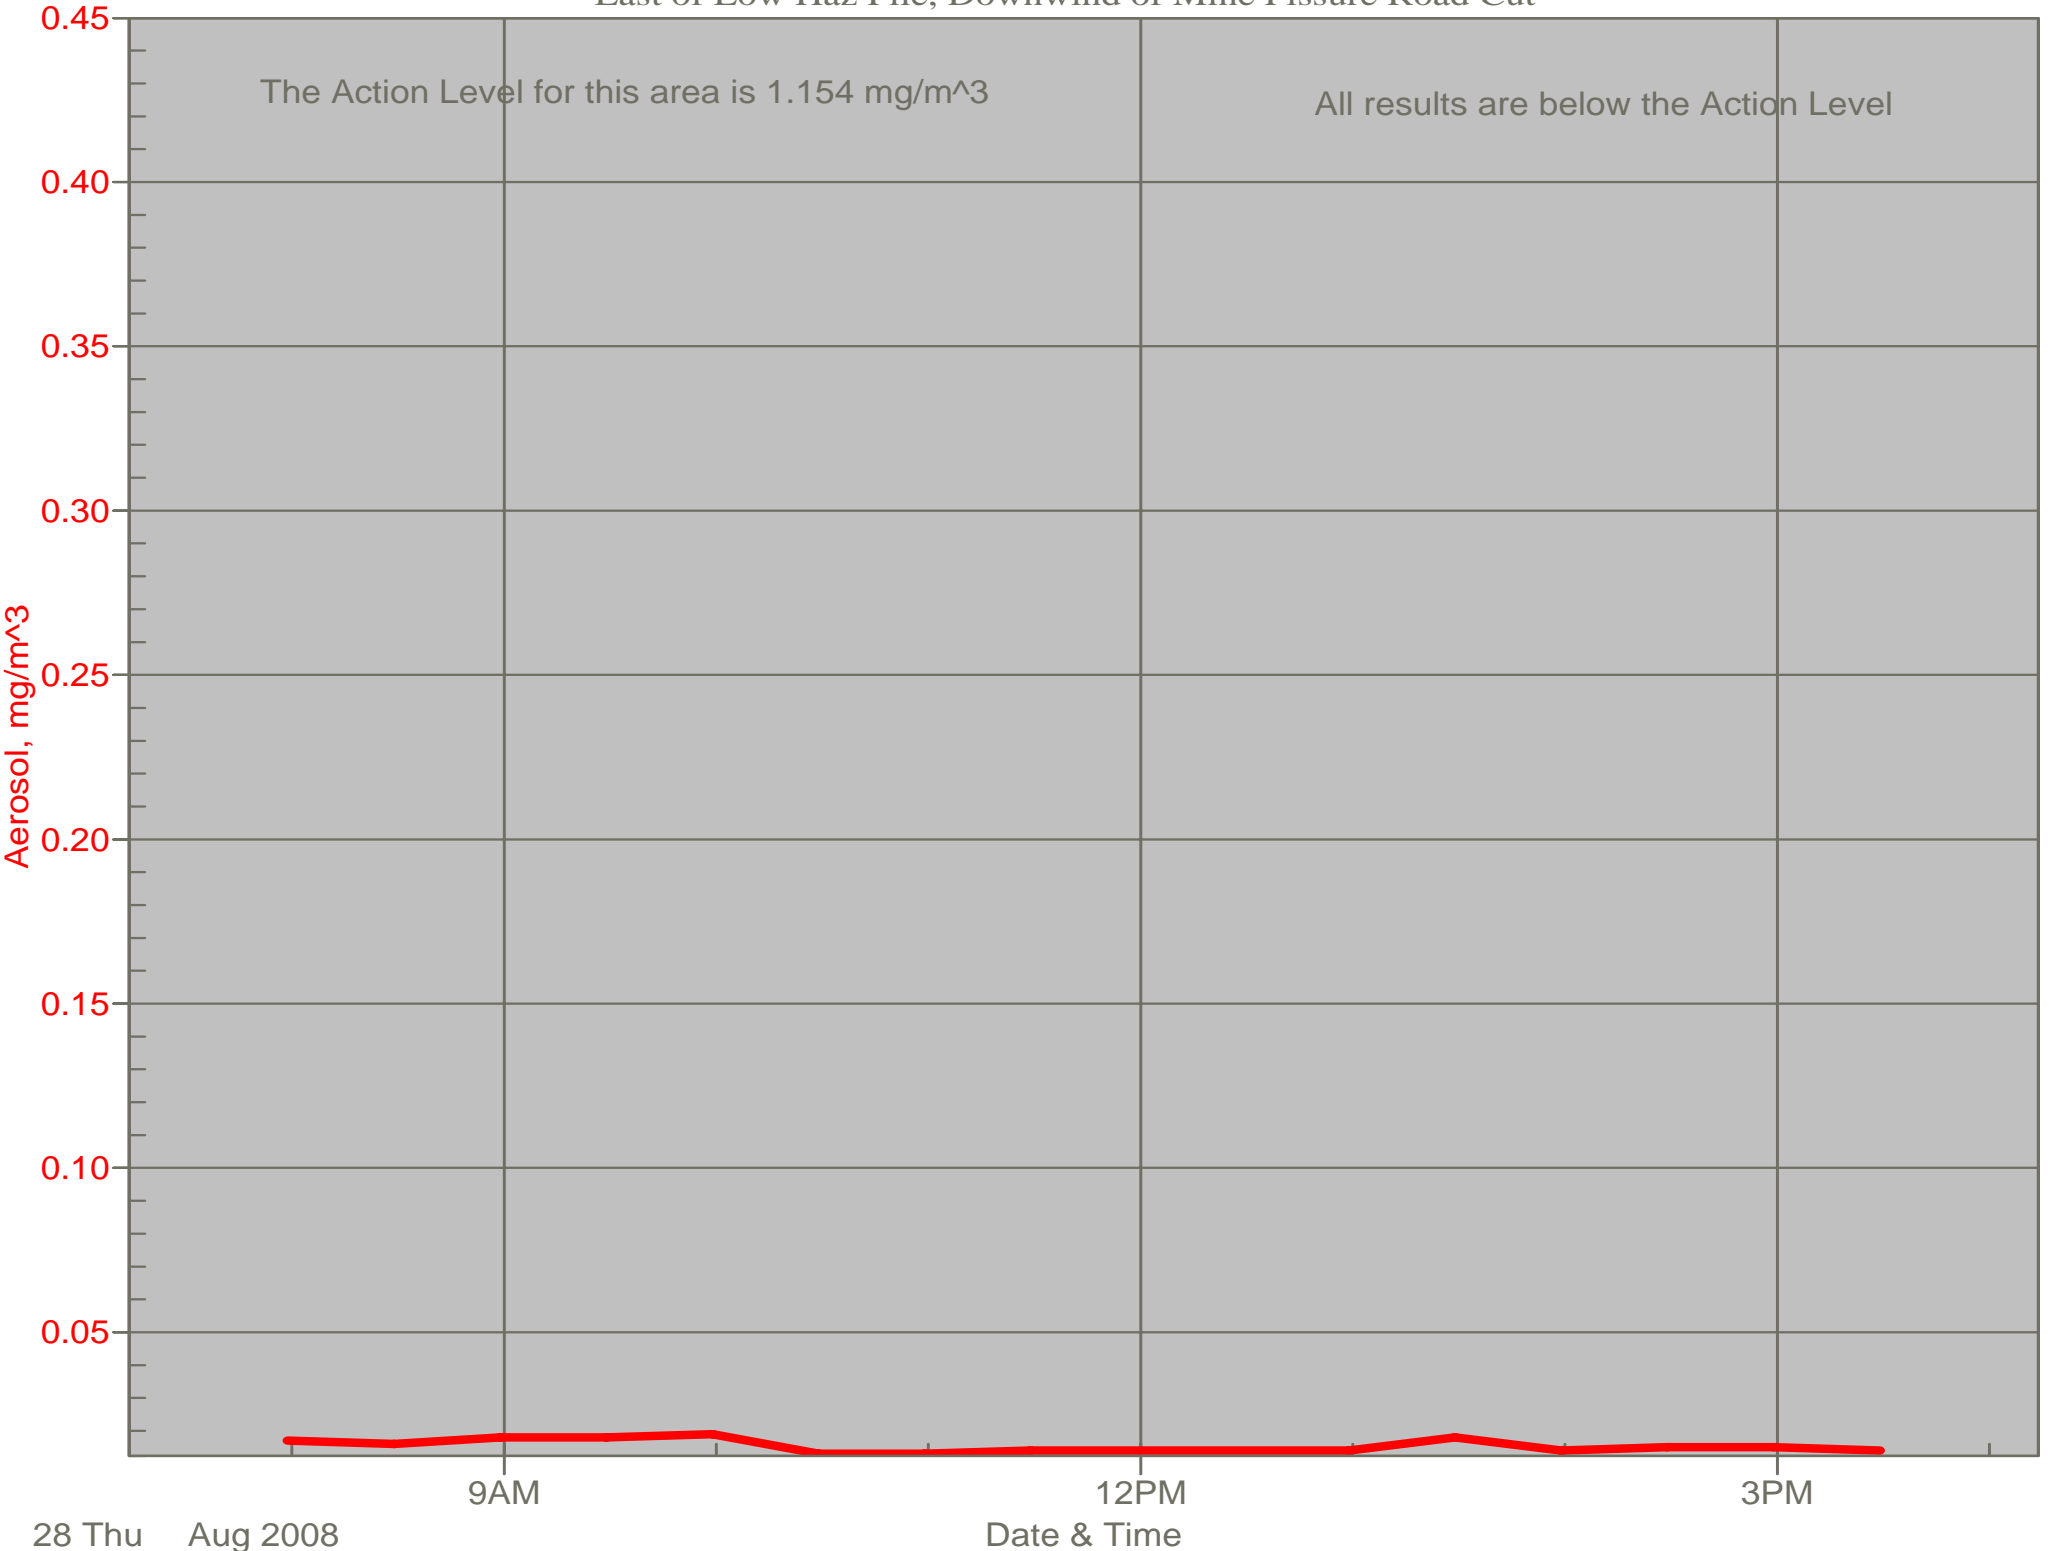
# Air Monitor 6

East of Low Haz Pile, Downwind of Mine Fissure Road Cut

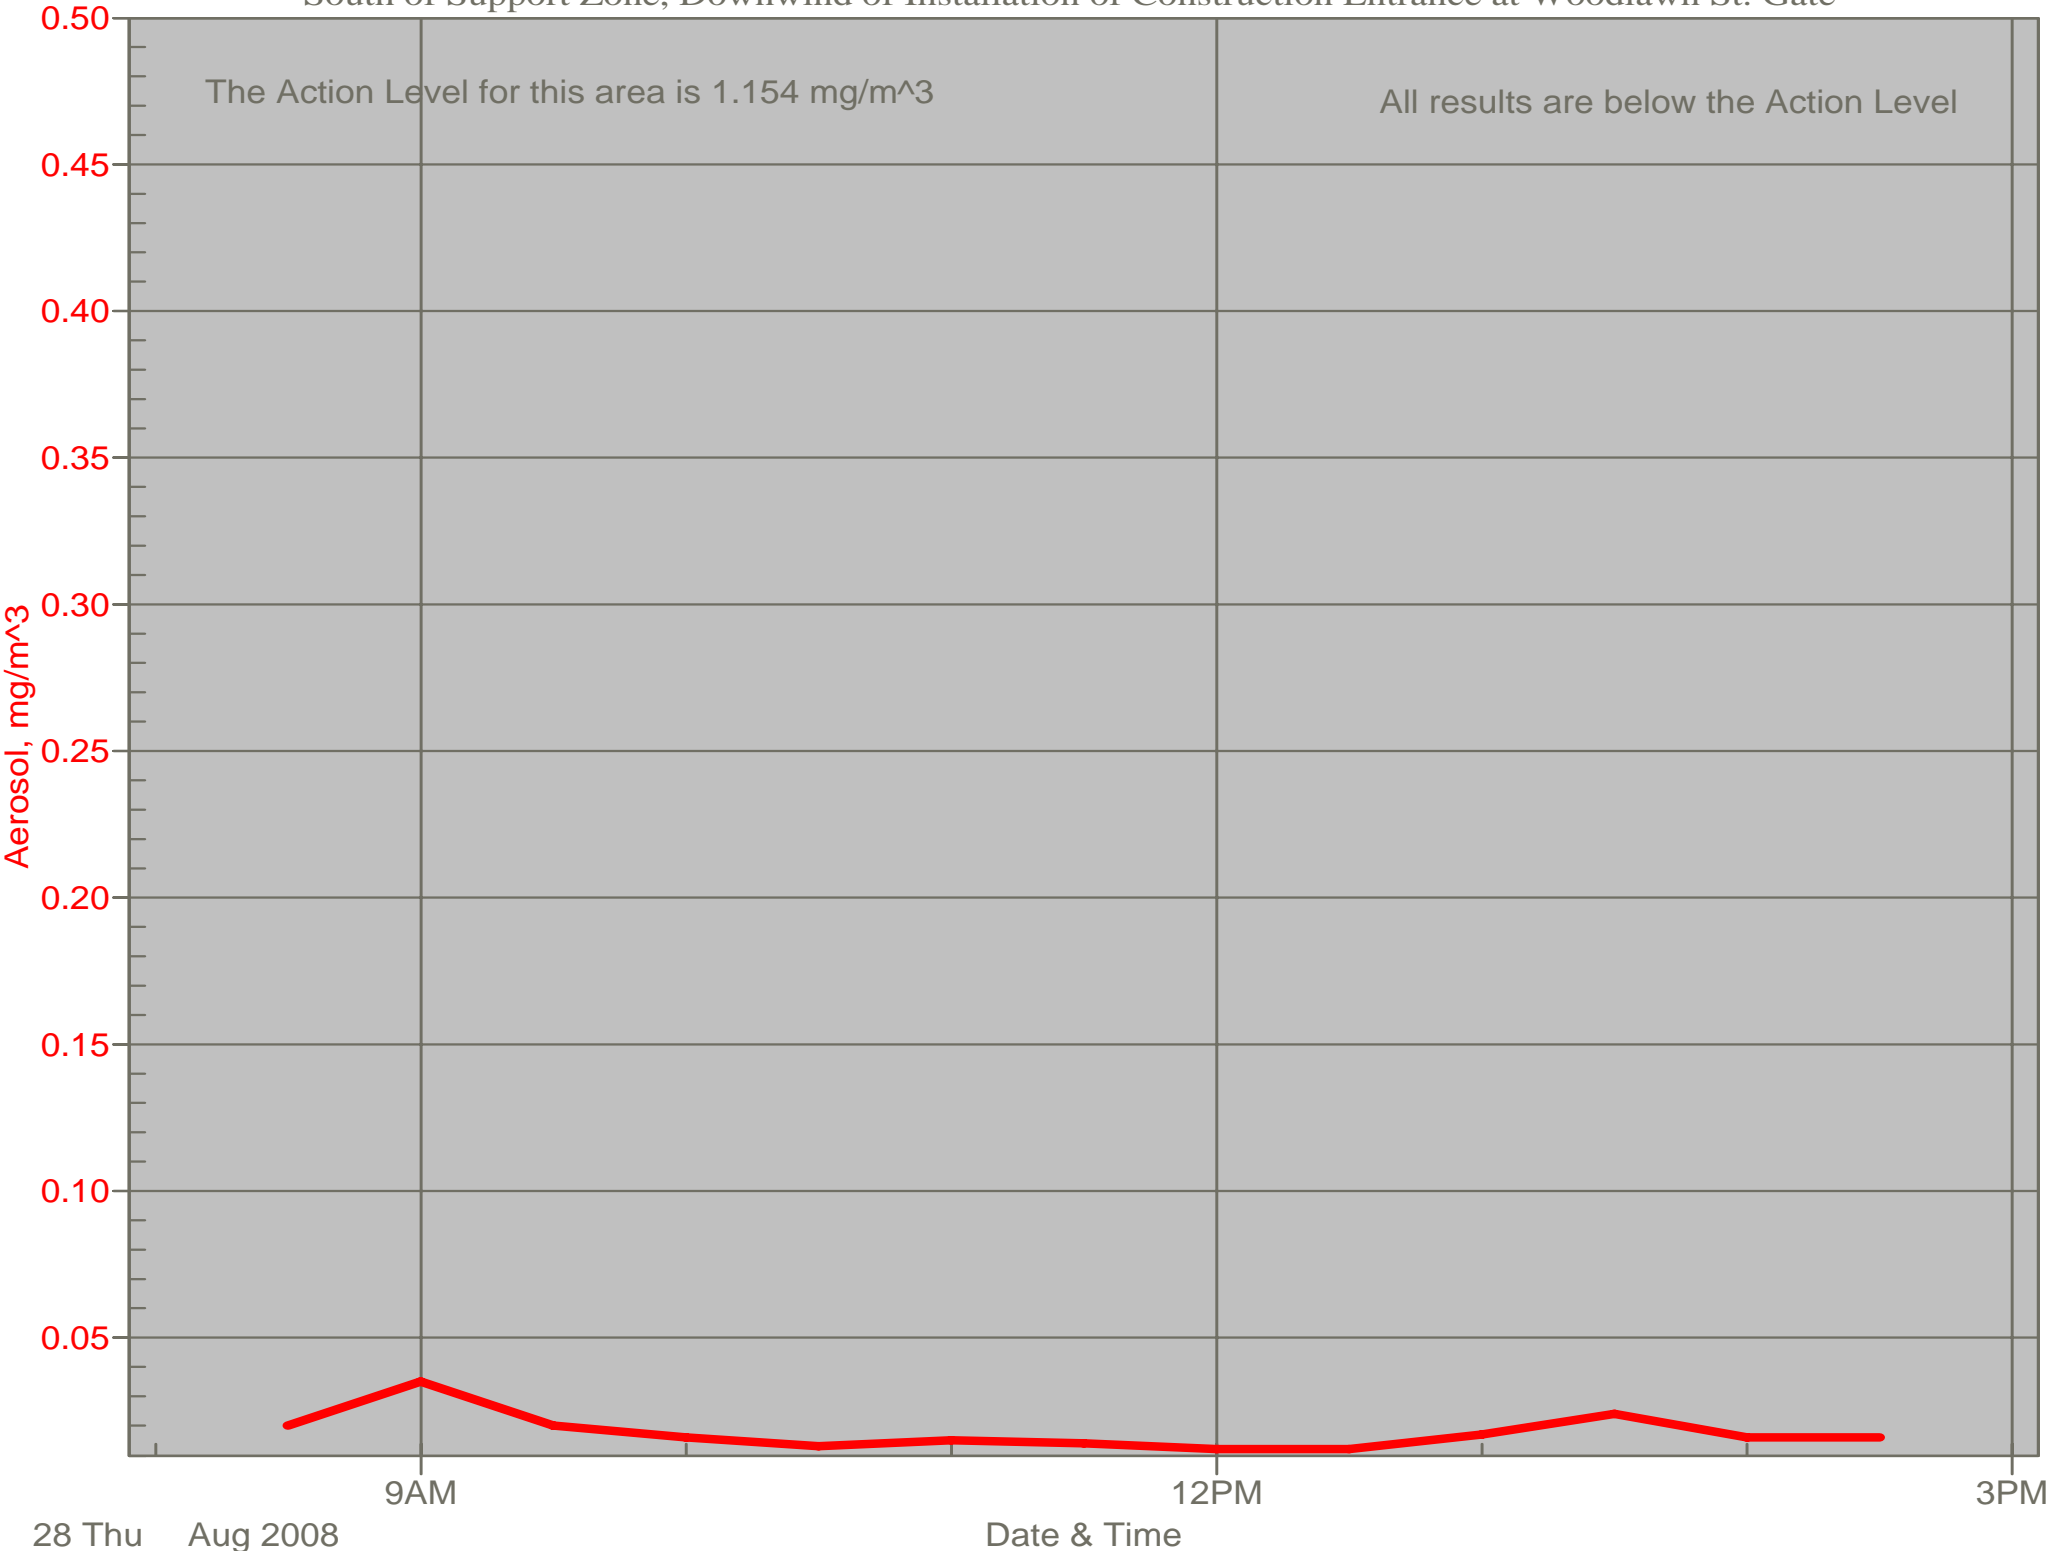
# Air Monitor 7

South of Support Zone, Downwind of Installation of Construction Entrance at Woodlawn St. Gate
