**Summary Report of Stormwater Management Activities
Marjol Battery Site
July 30 through August 3, 2009**

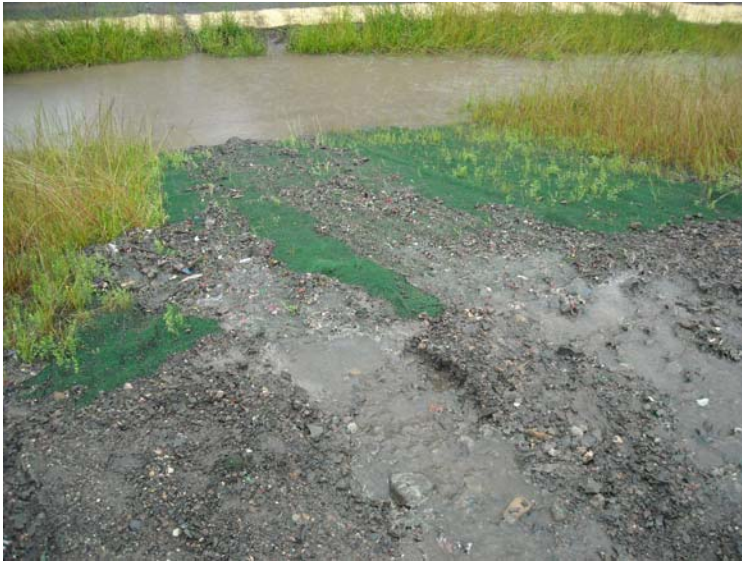
On Friday, July 31, 2009 accumulated stormwater overtopped the Containment Area (CA) Berm and flowed into the South Swale leading into the sediment basin. Battery casings and sediment were visible on the top of the berm and along the slope of the South Swale at several locations (see pictures below). According to the on-site weather station a total of 1.19" of rain was received July 31, 2009. The following text outlines the approximate timeline of the events that preceded and followed the overflow.

Picture 1: Battery casings, sediment, and debris washed over CA berm

and the metal grate was replaced to prevent direct rainfall from entering the outlet structure. Additionally, SCE graded along the CA berm to add additional berm height to prevent additional flow out of the CA.

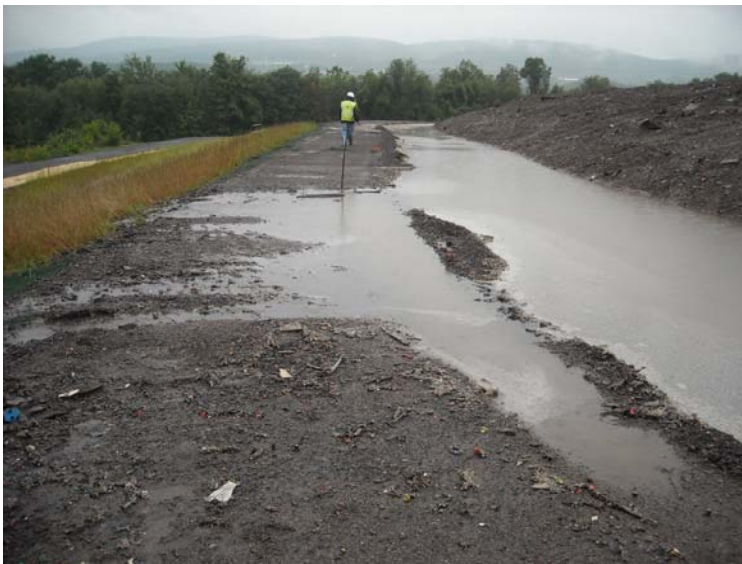
At approximately 1100, Gannet Fleming's representative notified AGC that water was topping the berm in several locations along the south and southwestern sides of the CA. AGC notified SCE immediately and reported to the area to assess the situation. See pictures provided. The pump placed at the west end of the CA was running at the time and had been running for the 24+ hours prior to the rain event. The water elevation within the CA was level with the berm or topping it and flowing into the sediment basin via the South Swale. The water elevation within the Sediment Basin was approximately six and a half feet in depth. The skimmer was above the water surface however, there was minimal flow from the discharge pipe. Upon inspection, AGC observed discharge off-site through the discharge channel.

Picture 2: Water overflow along south section of CA berm

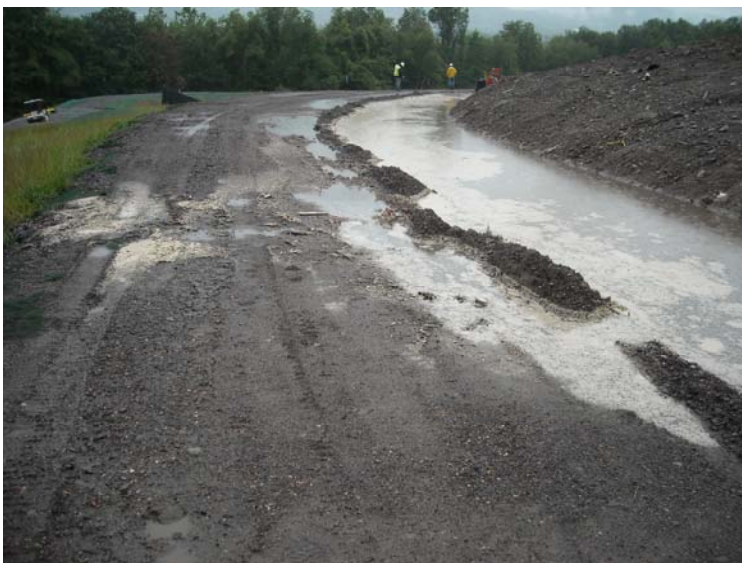
Picture 3: Overflow and water level at Southwest corner of CA berm

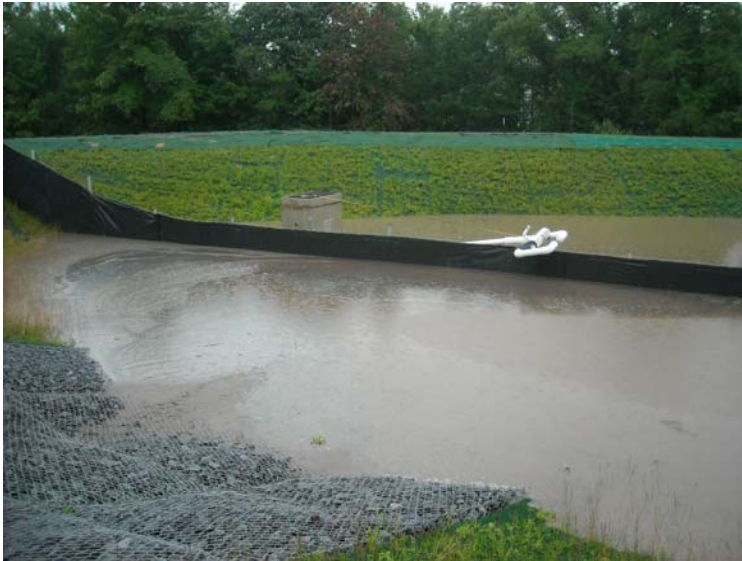
At approximately 1000 on Friday morning AGC field personnel were at the Sediment Basin raising the skimmer in preparation for the forecasted storm event. The skimmer was raised several additional feet to rest on the top of the baffle. The purpose of raising the skimmer was to prevent leakage through the skimmer into the outlet structure and discharge. No flow was observed out of the discharge pipe. After the skimmer was in place, field staff returned to the support zone and heavy rain started began. All water, at that point, was being controlled within the Containment Area. Heavy flow, generated from non-contaminated areas, was noted in the South Swale.

Picture 4: View of Sediment Basin and outlet structure. Skimmer was raised above waterline prior to storm event.

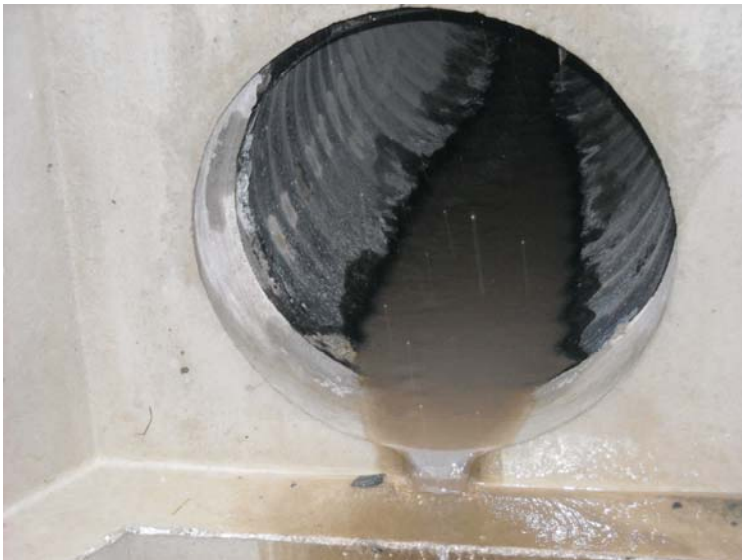
Picture 5: Flow into discharge channel from outlet structure

At AGC's request, SCE mobilized an additional pump to the discharge channel in order to pump the water accumulating in the channel back into the sediment basin. SCE also placed a plug within the skimmer's interior outlet structure to prevent further discharge into the channel. Flow out of the discharge pipe was discontinued at this time. Prior to leaving the Site for the day SCE resealed the top of the outlet box with poly and plywood

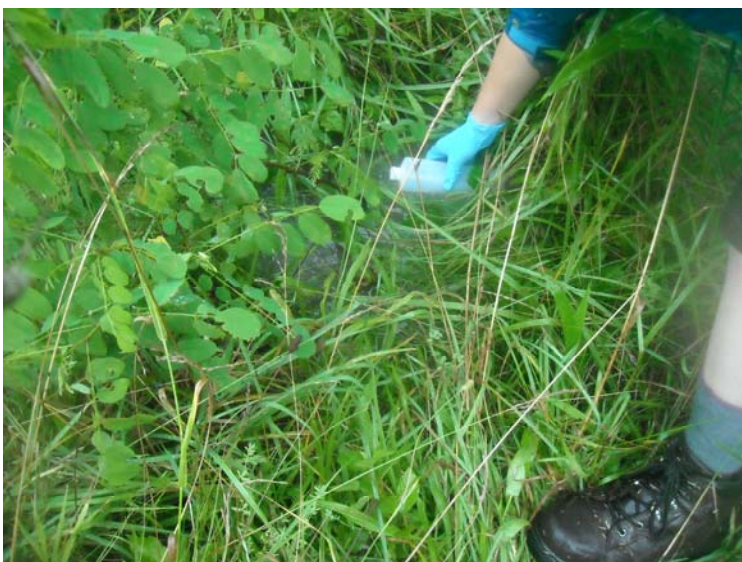
At 1145 AGC collected a water sample from the discharge point of the channel on the exterior side of the fence near HV-4. A duplicate sample as well as an MS/MSD was collected from the same location. An additional sample was collected at 1300 from the water in the Sediment Basin at the entry point of CD-15. All samples were sent to the laboratory for total and dissolved lead analysis. The preliminary data is attached. The acute and chronic National Recommended Water Quality Criteria for dissolved lead are 650 ug/L and 25 ug/L respectively. Results of the analysis are below:

Picture 6: Discharge sampling location for total and dissolved lead (outside of fence line, southwest corner of Site)

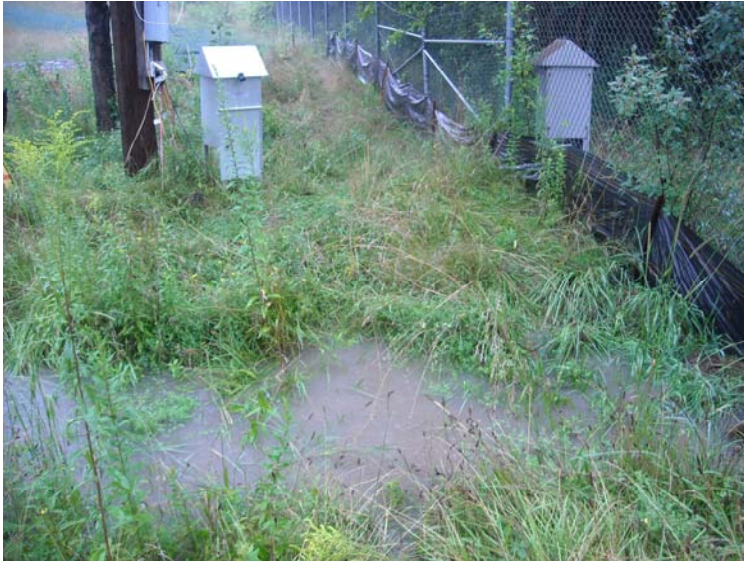
Picture 7: Flow in discharge channel

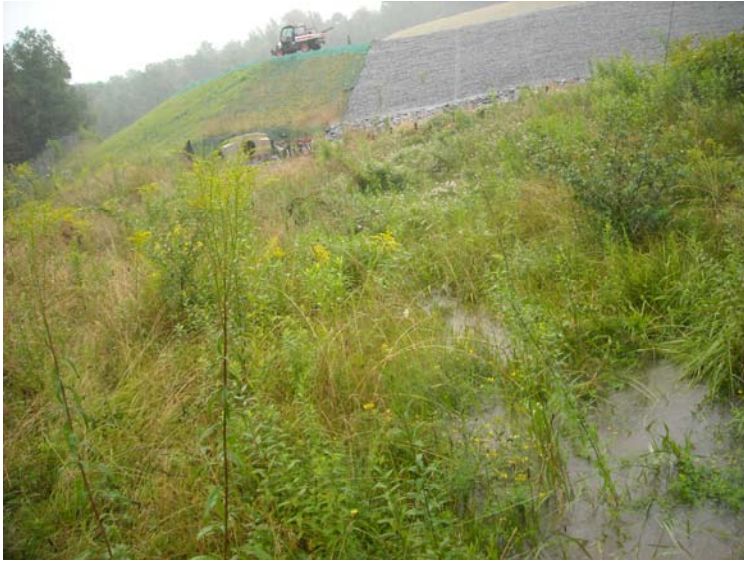
Picture 8: View of discharge channel looking toward outlet structure from Site discharge point near HV-1

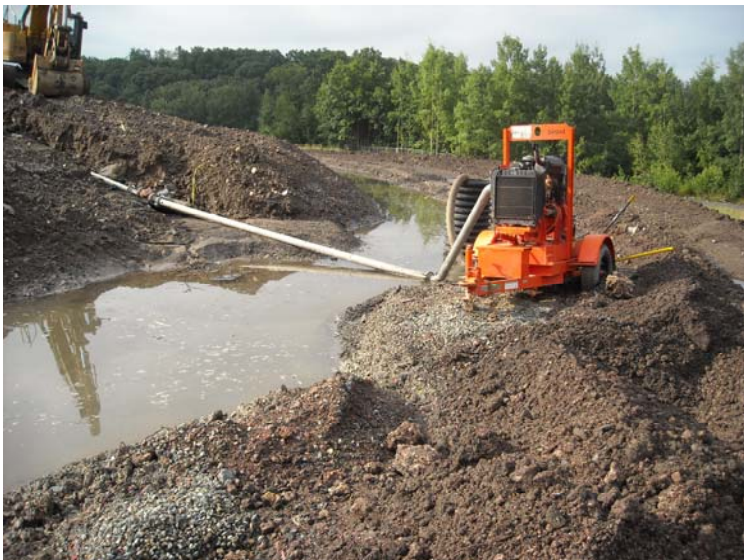
Picture 9: Pumping station set up at west end of CA
