**POST-CLOSURE INSPECTION FORM
MARJOL BATTERY SITE, THROOP, PENNSLYVANIA**

Date of Inspection: May 5, 2011 **Day of Inspection:** Thursday **Time Started:** 1030 **Time Completed:** 1300

MARJOL BATTERY SITE
SITE GRADING AS-BUILT (FACILITY)

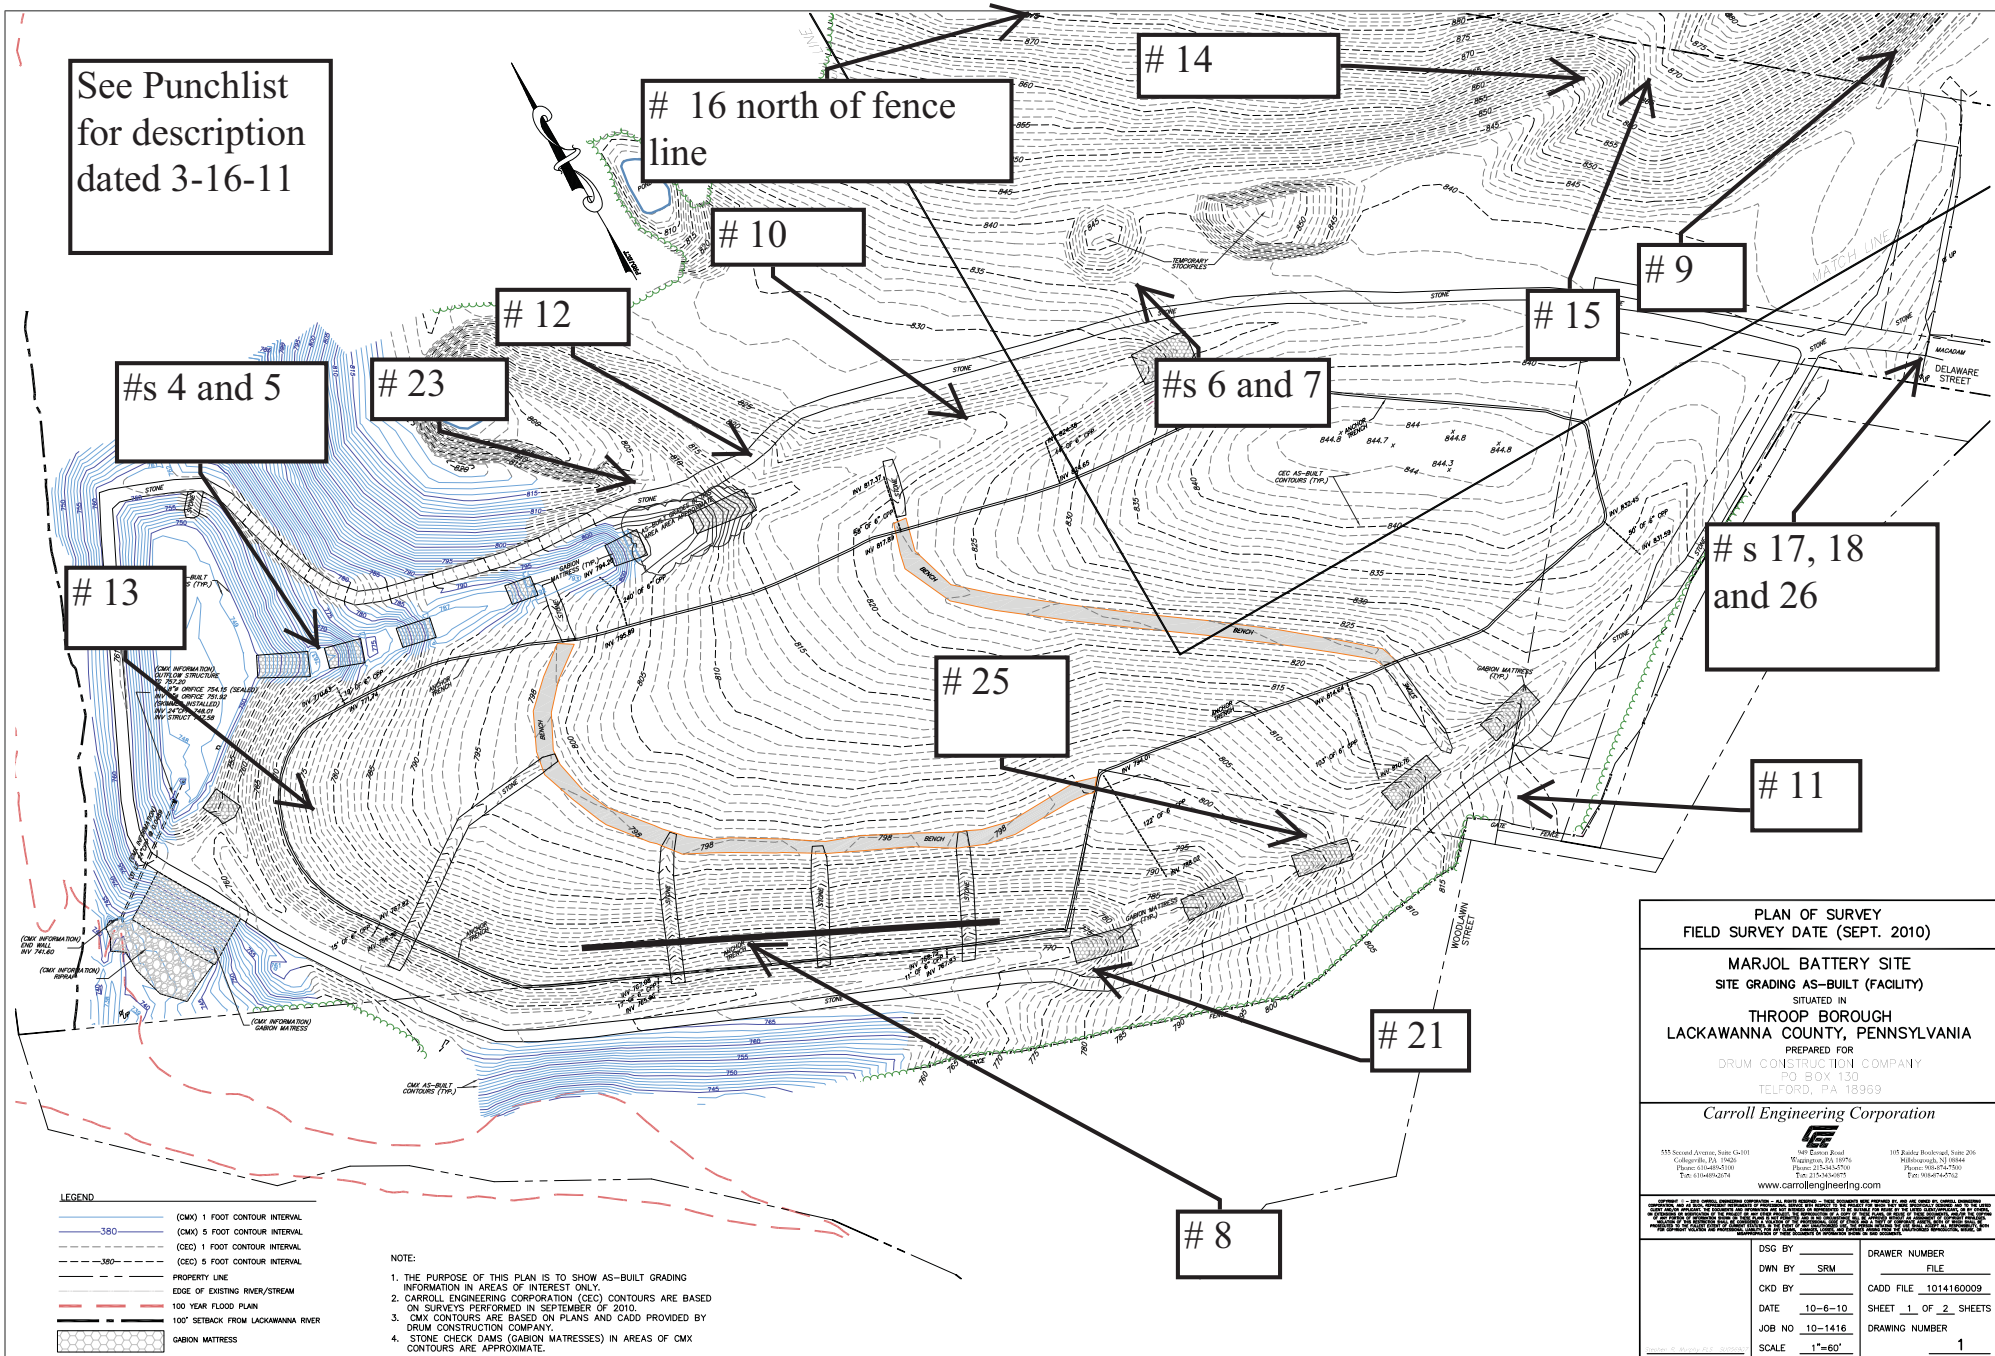
PUNCHLIST (03-16-11)
(See attached sketch for select locations)

See Punchlist
for description
dated 3-16-11

1. Remove chain link and gate posts at Woodlawn Street and along Delaware Street.
2. Remove remaining concrete above the ground surface from fence post removal (check perimeter fence footprint).

3. Remove unused fence debris and temporary panels from the site (site-wide).
4. Place additional anchor pins in the permanent ECM placed between CD-6 and CD-7.

5. Remove and replace gabion mattress lid on CD-6 damaged during ECM installation upslope of CD-7.
6. Repair erosion rills and grade area south of stockpile area.

7. Install additional Curlex/jute mat ECM on non-stabilized areas proximate to the stockpiles.
8. Repair any ripped silt socks (wrap with geotextile) and repair rills below socks on the CA.

9. Repair the erosion on the North Woods front slope (along the berm and at the base of the slope).
10. Repair erosion issues along the side slopes of the North Swale and repair ECM (can be found intermittently throughout the channels of the swale).

11. Stabilize area at Woodlawn Street gate (seed and jute mat).
12. Repair erosion along the access road north of CD-2.
13. Repair the minor erosion rills on the western slope and the 4:1 slope of the CA.

14. Repair the erosion rills in the North Ravine.
15. Apply topsoil on haul road adjacent to North Ravine, seed and stabilize with ECM. (post basin conversion and perimeter fence removal).

16. Repair the erosion at the former haul road adjacent to the installed perimeter fence.
17. Install two 4" x 4" tie back posts for Delaware Street barrier gate (included in fence installation detail).

18. Establish drop pin holes for Delaware Street barrier gate (following basin conversion).
19. Remove High-Volume air monitors from site (located near Woodlawn St. gate).
20. Repair low spots on Access Road (review steeper areas on north and south sides of CA).
21. Remove eroded stone from south slope of CD-14.
22. Repair stakes on silt socks on CA.
23. Repair chain link fence at tie-in with split rail south of Area B.
24. Repair chain link fence post along northern perimeter (fence posts leaning).
25. Repair erosion and fill in hole north of CD-12.
26. Base of removed gate posts on Delaware Street. Grout post and finish area flush to surrounding asphalt.
27. Complete split rail fence installation (following basin conversion).
