**POST-CLOSURE INSPECTION FORM
MARJOL BATTERY SITE, THROOP, PENNSLYVANIA**

Date of Inspection: November 19, 2010 **Day of Inspection:** Friday **Time Started:** 1000 **Time Completed:** 1200

Attendees: Kevin O'Rourke, Jamie Heimbach, Lisa Ayers (AGC), Arnie Boyer (SCE), Len Zelinka (PADEP)

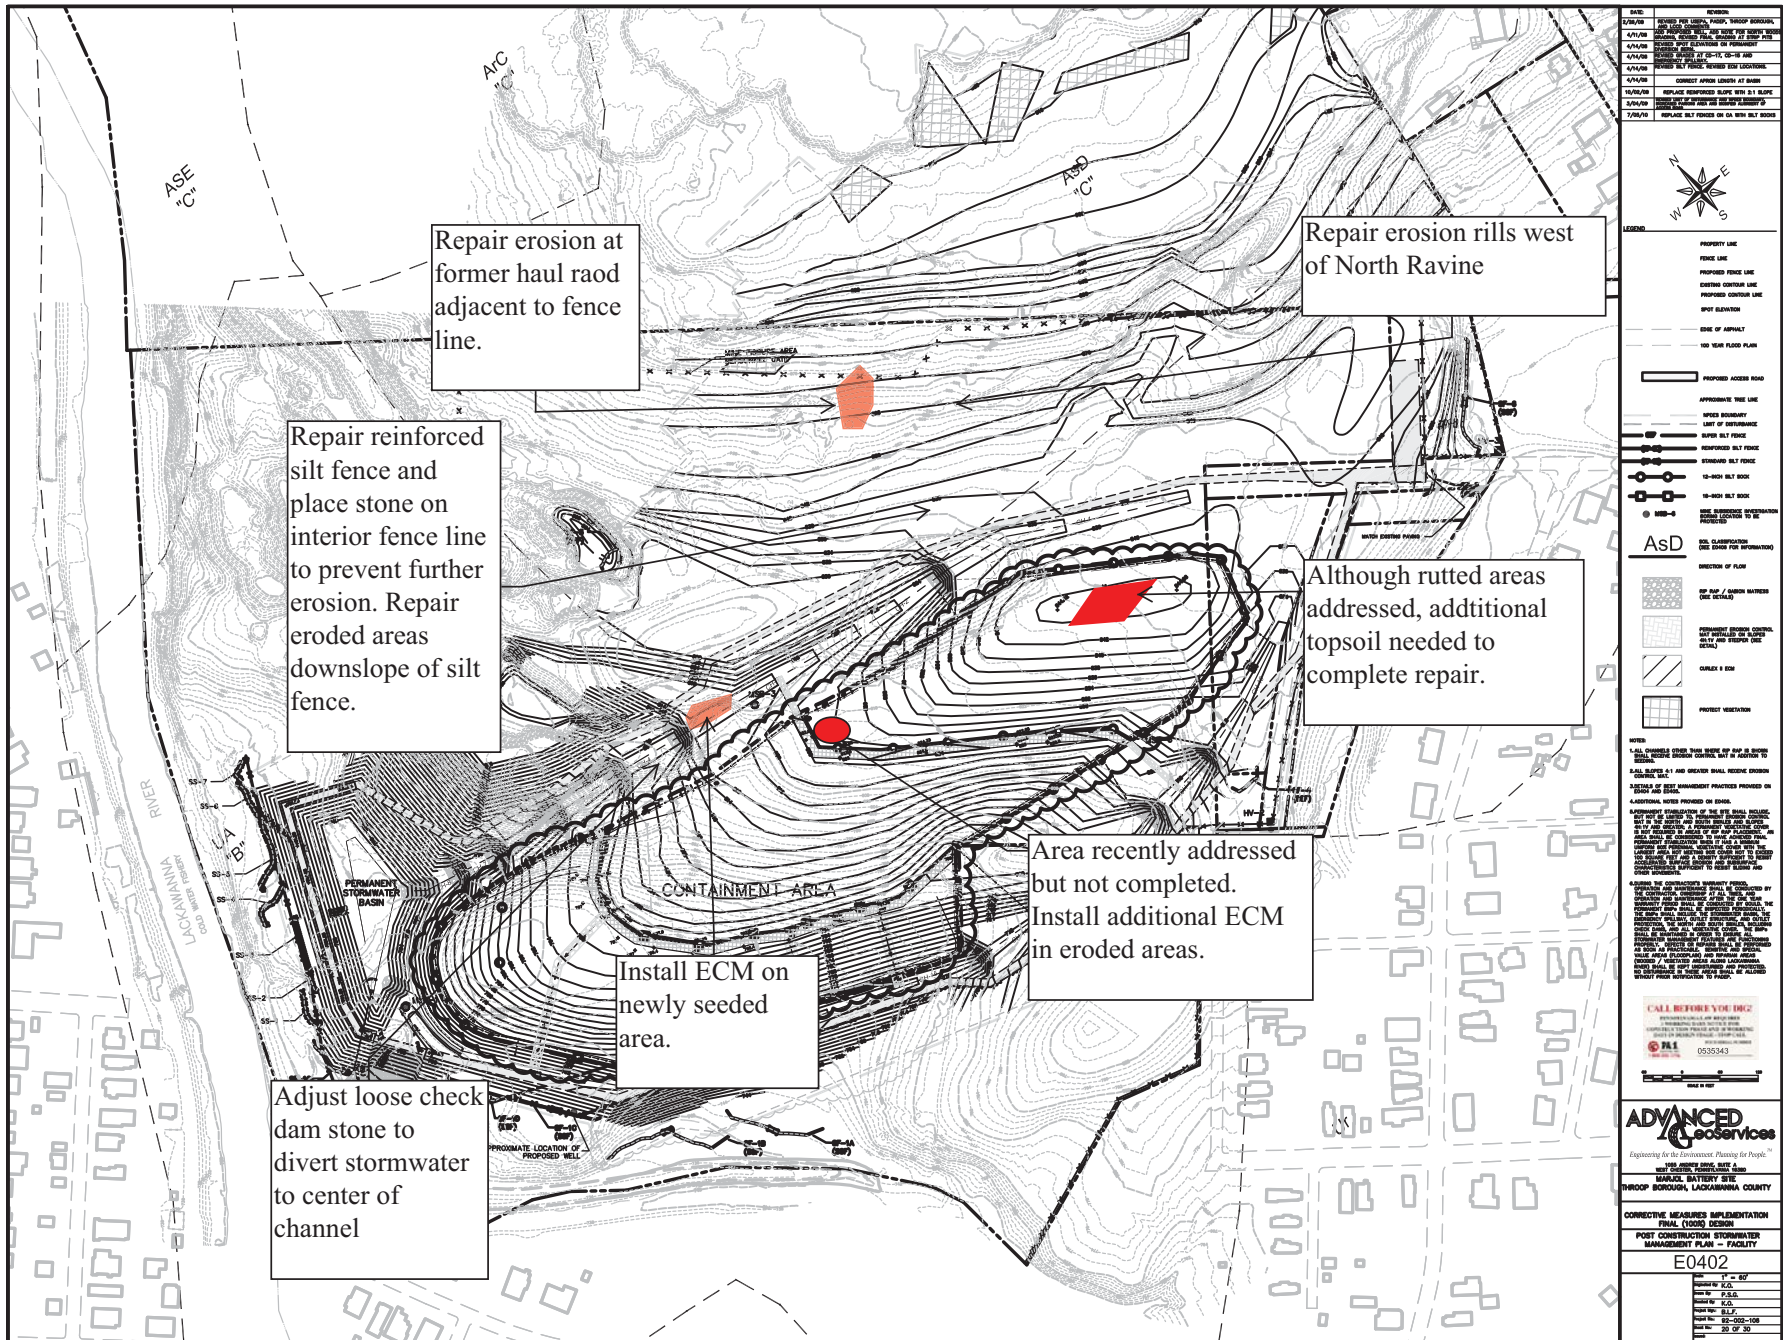
E0402

Inspection Checklist: Complete the checklist for all items. If deficiencies were observed during a previous inspection, note if conditions have changed or been repaired since the previous inspection. See O&M Plan for additional information regarding each item. Sketch areas of erosion, ponded water, lack of vegetative cover and other items requiring repair on a site plan and attach to this form.

ITEM	Y / N	COMMENTS	MARK IF REPAIR NEEDED
<i>Containment Area Cap</i>			
Has proper vegetative cover been established? (at least 90 percent surface area coverage of live, growing species, with the largest individual surface area not meeting the 90 percent coverage requirement not to exceed 100 square feet)	No	Additional coverage needed on the eastern areas of the CA. Steep slope and western areas have improved. Recent seeding has germinated and new grass growth is continuing.	
Are trees, shrubs or deep rooted plants present on the cap?	No		
Is additional seeding, mulching or watering needed?	No	Soil is moist from recent rain events. No additional water needed at this time. Additional ECM to be placed north of top bench as shown on attached sketch.	X
When was mowing last conducted?		October 23, 2010. No need for additional mowing at this time.

ITEM	Y / N	COMMENTS	MARK IF REPAIR NEEDED
Is damage from burrowing animals present?	No		
Are the silt socks in the CA functional?	Yes		
Is erosion occurring under the silt socks?	Yes	Minor erosion in specific points. Grass growth density is increasing causing less erosion beneath socks.	X
<i>Restored Excavation Areas</i>			
Has proper vegetative cover been established? (at least 90 percent surface area coverage of live, growing species, with the largest individual surface area not meeting the 90 percent coverage requirement not to exceed 100 square feet)	No	Areas of the Site (North woods) have the required coverage except former haul roads. The Facility portion is improving.	
Is additional seeding, mulching or watering needed?	No	Areas of the site with less than required coverage were reseeded on October 22, 2010.	
When was mowing last conducted?		October 23, 2010. No need for additional mowing at this time.

ITEM	Y / N	COMMENTS	MARK IF REPAIR NEEDED
Are significant erosion rills or soil cracking present ($\geq 9''$)?	No	Minor rills in North Ravine area less than 9 inches.	X
Is ponding present? If yes, note depth.	Yes	Minor puddles downstream of permanent diversion berm.	
Is settlement or subsidence visible?	No		
Are slopes visually stable?	Yes		
Are erosion and sedimentation controls functioning properly? (silt socks, silt fence, RCE, etc.)	Yes	Repair to silt fence south of temporary stockpiles needs to be addressed.	X
<i>Access Roads</i>			
Are significant cracks, potholes, or erosion present?	No		
Is the roadway in adequate working order?	Yes		
<i>Fencing</i>			
Is the fence rusted or deteriorated?	No	New split rail fence and gates recently completed.

ITEM	Y / N	COMMENTS	MARK IF REPAIR NEEDED
Is the fence cut or breached?	No	Temporary chain link at split rail fence gap to be secured more effectively.	X
Is burrowing or tunneling present under the fences?	No		
Are all gates and locks operating?	Yes		
Are required signs present?	Yes	Additional "Posted Private Property" signs to be installed.	
Are there any signs of trespassing, including the North Woods Trails?	No		
<i>Stormwater System</i>			
What is the water level in the stormwater basin?		Approximately 4 feet.	
Are there indications of animal activity?	No	Geese and Ducks using the basin.	
Is adequate vegetation present?	Yes		
Is erosion occurring in the basin or channels?	Yes	Erosion occurring at CD-7 where the North Swale enters the basin. Repairs required.	X
