**Summary Report of Stormwater Management Activities  
Marjol Battery Site  
August 10 through August 14**

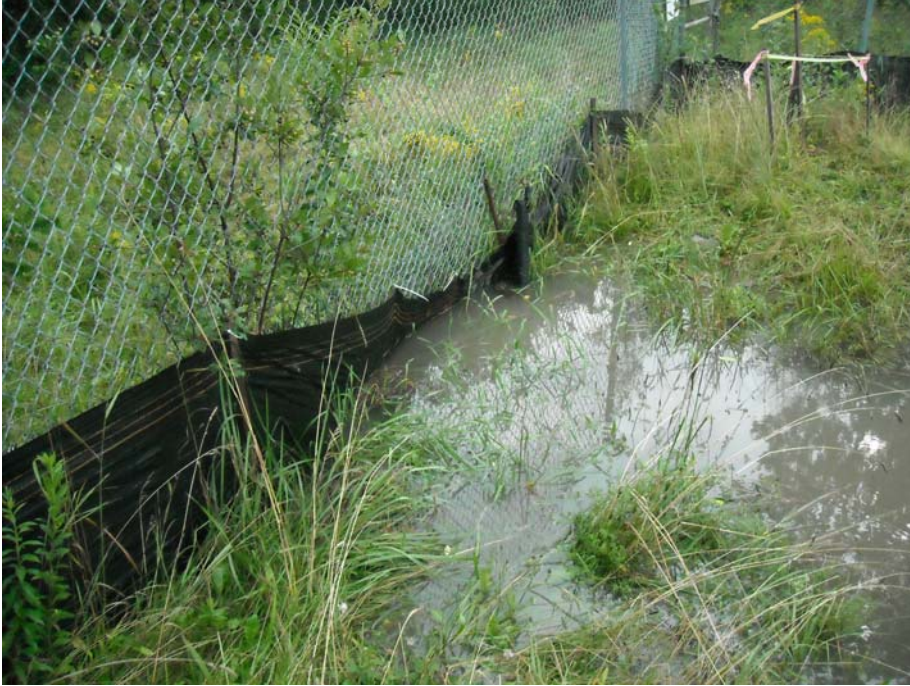
According to the on-site weather station a total of 0.62 inches was received on August 9, 2009. An intense rain event occurred on August 10, approximately between 1730 and 1800 at the Site and approximately 0.7" of rain was received. AGC field personnel inspected the CA for water capacity. Once reaching the area, the water had already begun to overflow the CA berm in one location as shown on the attached sketch. The pump in the CA was not operating at the time. AGC called SCE to come to the Site to start the pump and help raise the skimmer to prevent discharge. The water in the discharge channel was transparent based on visual observations. AGC performed a turbidity test on the discharge which was 72.5.

Picture 1: Discharge Channel  
Following CA Overflow (08-10-09)

SCE arrived on-site and immediately started the pump. The water level in the CA was quickly lowered as water was pumped to Area B. SCE reversed the float on the skimmer and raised it onto the baffle fence. Discharge from the outlet pipe was halted at this time; however water continued to flow through the discharge channel.

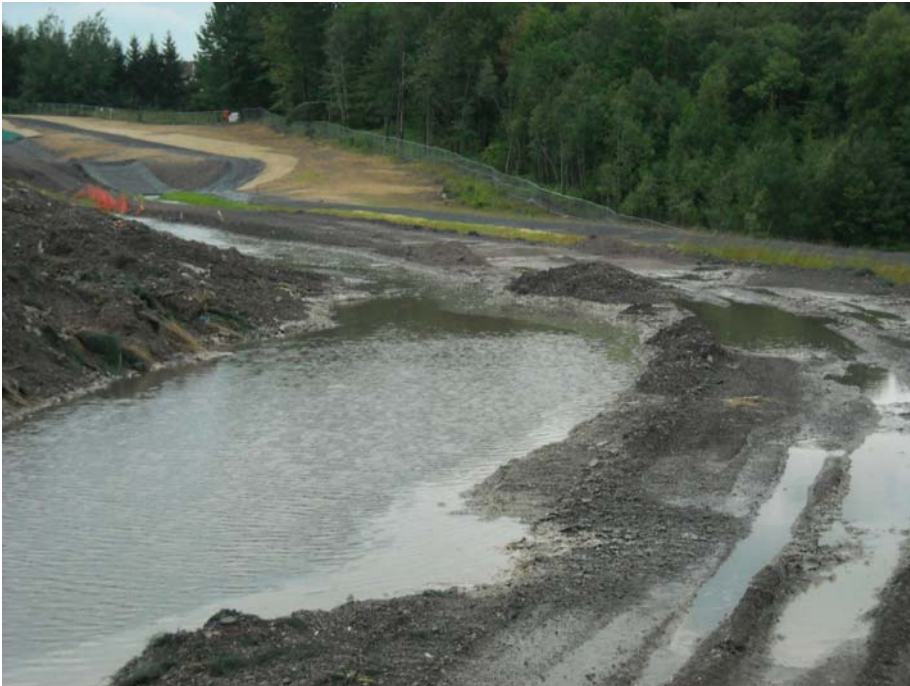
On Monday, August 10 and Wednesday August 12, 2009 accumulated stormwater overtopped the Containment Area (CA) berm and flowed into the South Swale leading into the sediment basin. Battery casings and sediment were visible on the top of the berm and along the slope of South Swale at several locations similarly to the July 31, 2009 occurrence. The following text outlines the approximate timeline of the events of the overflow occurrences.

Picture 2: Water  
overflow along section  
of CA berm (08-10-09)

On Wednesday August 12, at the direction of AGC, SCE placed the skimmer back in the basin to continue discharge. SCE increased the basin berm another 1.5 to 2 feet around the western and southwestern berm to increase stormwater capacity in the CA. A rope was tied to the skimmer to allow easy access in order to stop discharge.

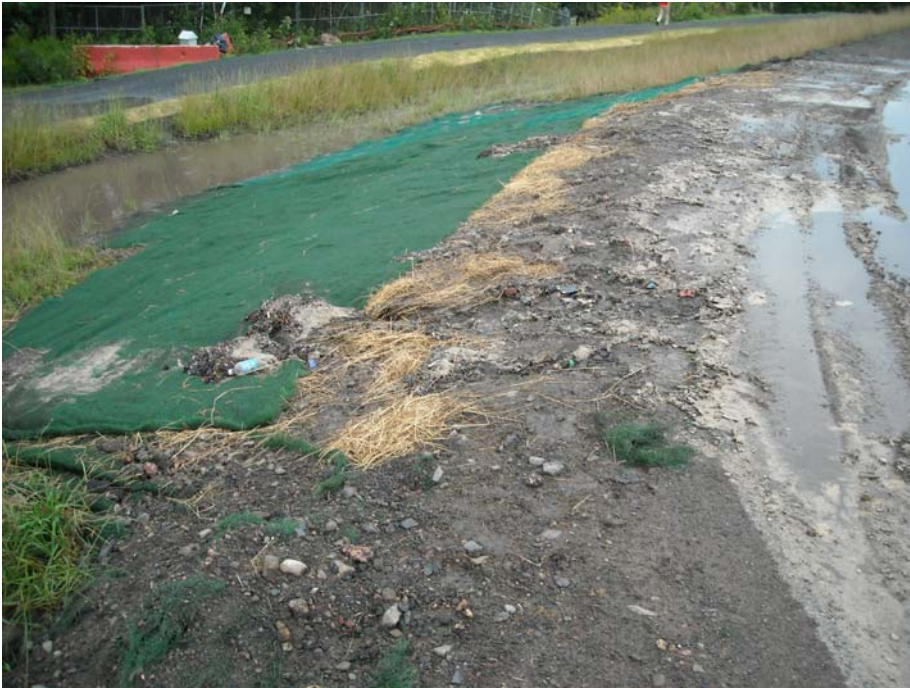
Picture 3: Overflow Area (08-10-09)

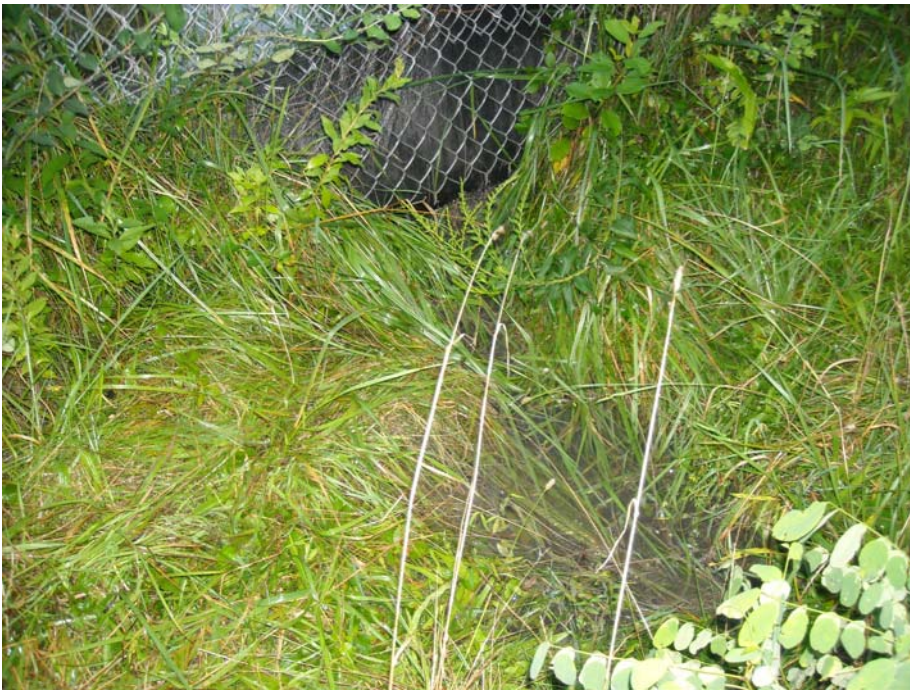
Picture 4: Off-site Discharge Water (08-10-09)

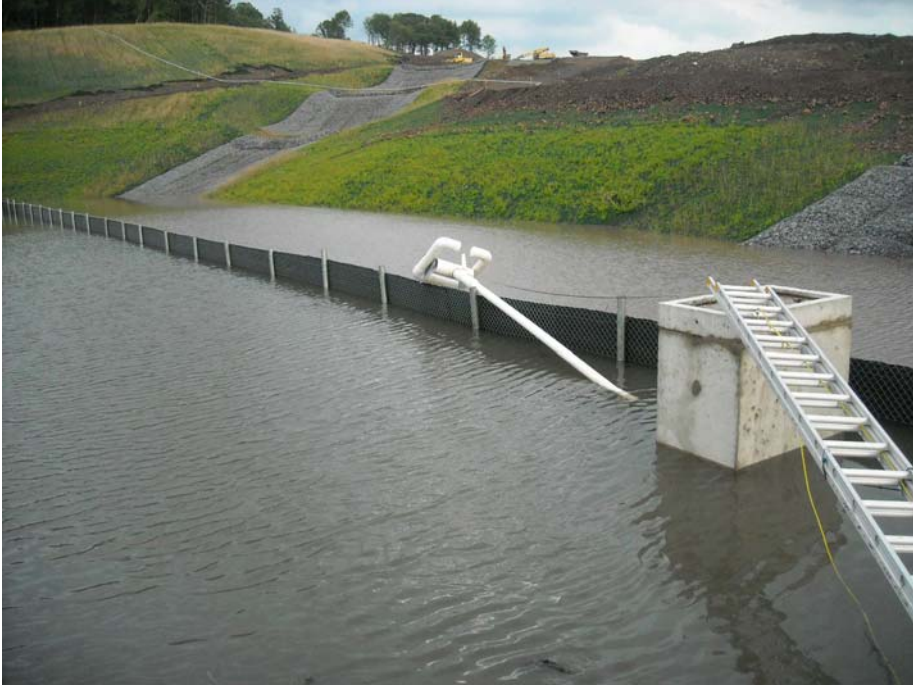
Picture 5: Basin Skimmer (08-10-09)

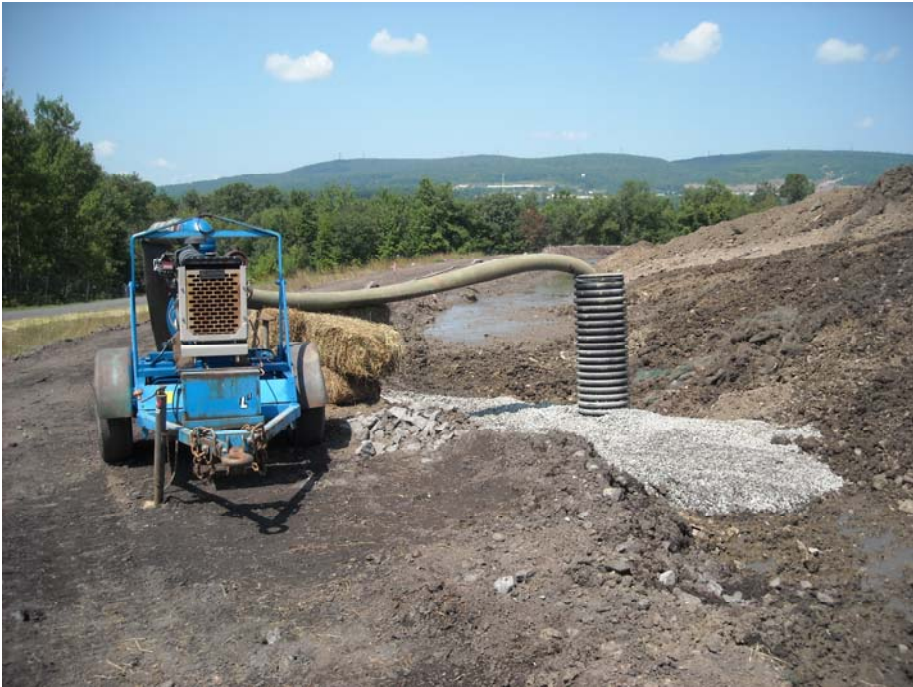
Picture 6: Additional Pump installed  
(08-15-09)

SCE placed an additional pump at the overflow area and connected a discharge pipe to Area B.

Although XRF analysis showed some contaminants did enter the South Swale, it did not affect the off-site discharge; the stormwater management system continued to function as designed. It is anticipated that the additional pump located at the overflow location will prevent additional overflows in the future.
