RE: January 25, 2010 Non-Compliance Report  
NPDES Permit No. PAI023508001  
Marjol Battery Site, Throop, Pennsylvania

#### Non-Compliant Discharge Event

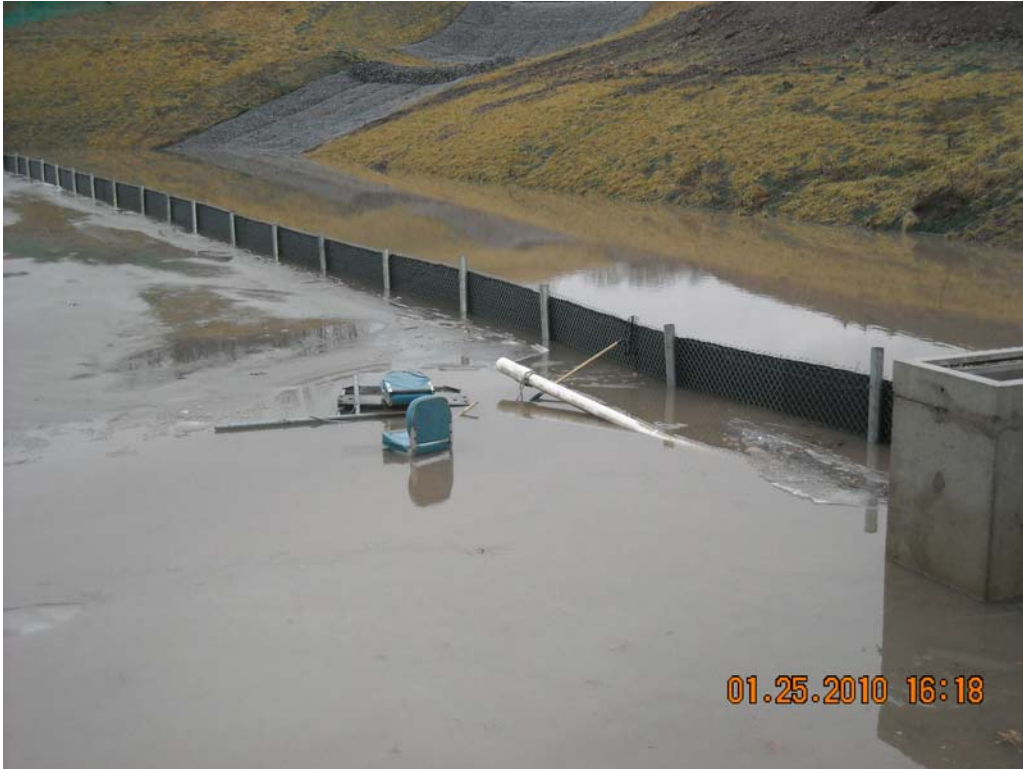
During a site inspection on January 22, 2010, Advanced GeoServices observed the skimmer was intact. The water in the basin was frozen and the water level was approximately 12 to 16 inches below the outlet structure /skimmer orifice. It is assumed that the skimmer head and skimmer arm separated due to thawing and movement of ice within the basin.

Skimmer arm above water surface 01-25-10

On January 26, 2010, SCE repaired the skimmer by reattaching the skimmer arm to the skimmer head and gluing with PVC bonding material in order for the skimmer to remain functional until basin conversion. Additionally, SCE tied a rope to the skimmer arm to allow a quick retrieval if similar circumstances arise. Following the repair, SCE tested the skimmer to ensure it was functioning properly. Advanced GeoServices was present to observe the resumed discharge. As the discharge was observed to be in compliance with the 250 NTU turbidity limit, the skimmer was allowed to continue operating.

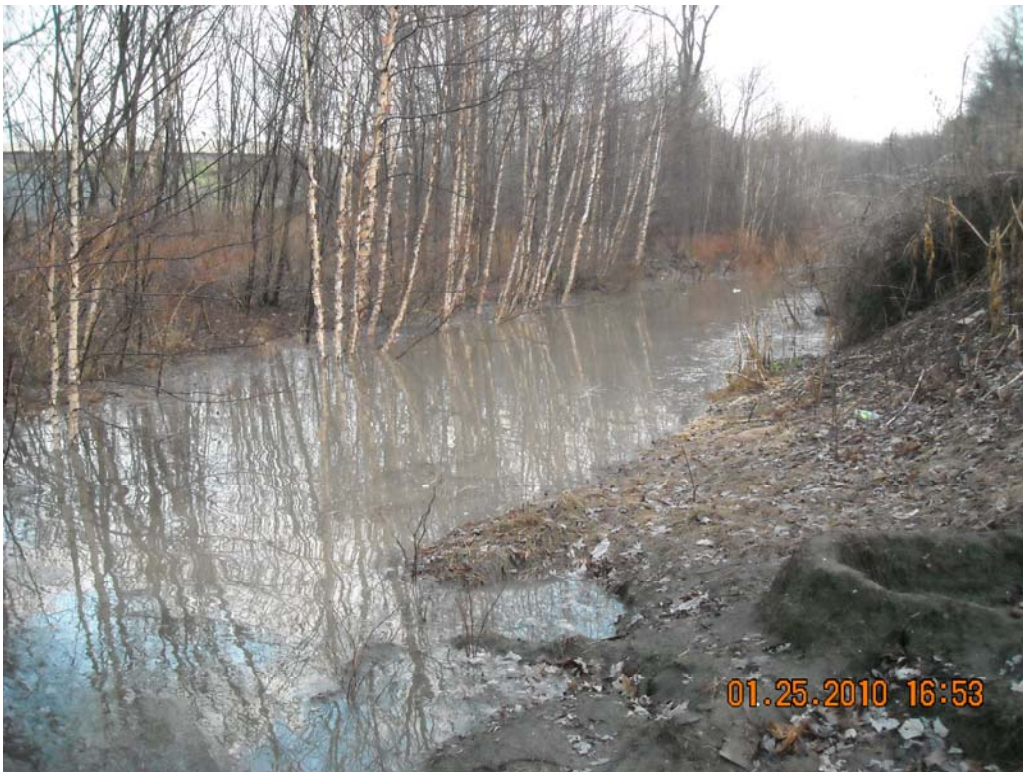
- Discharge Channel at Sulphur Creek (rip rap apron) – 1,840 NTUs, 1,918 NTUs
- Sulphur Creek approximately 25 feet downstream of discharge channel – 168 NTUs, 145 NTUs, 112 NTUs
- Sulphur Creek approximately 15 feet upstream of discharge channel – 93.9 NTUs, 90 NTUs
- Confluence of Sulphur Creek and Lackawanna River – 119 NTUs, 116 NTUs
- Lackawanna River Approximately 15 feet downstream of confluence of Sulphur Creek – 132 NTUs

Sulphur Creek downstream of discharge channel 01-25-10

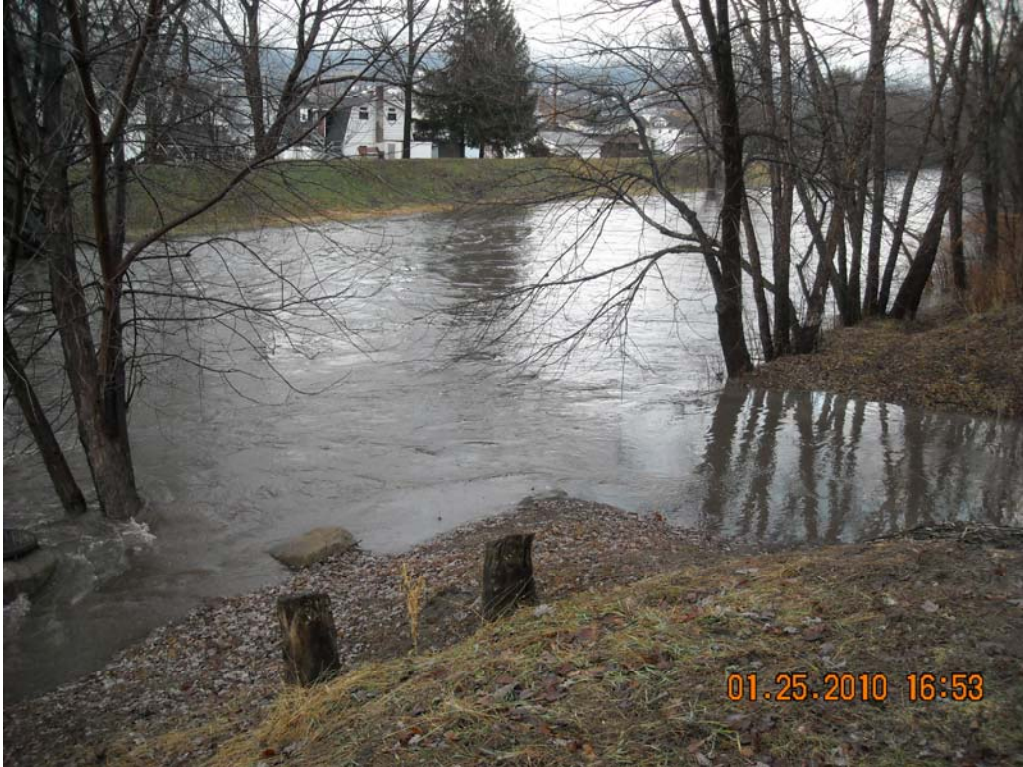
Confluence of Sulphur Creek and Lackawanna River 01-25-10

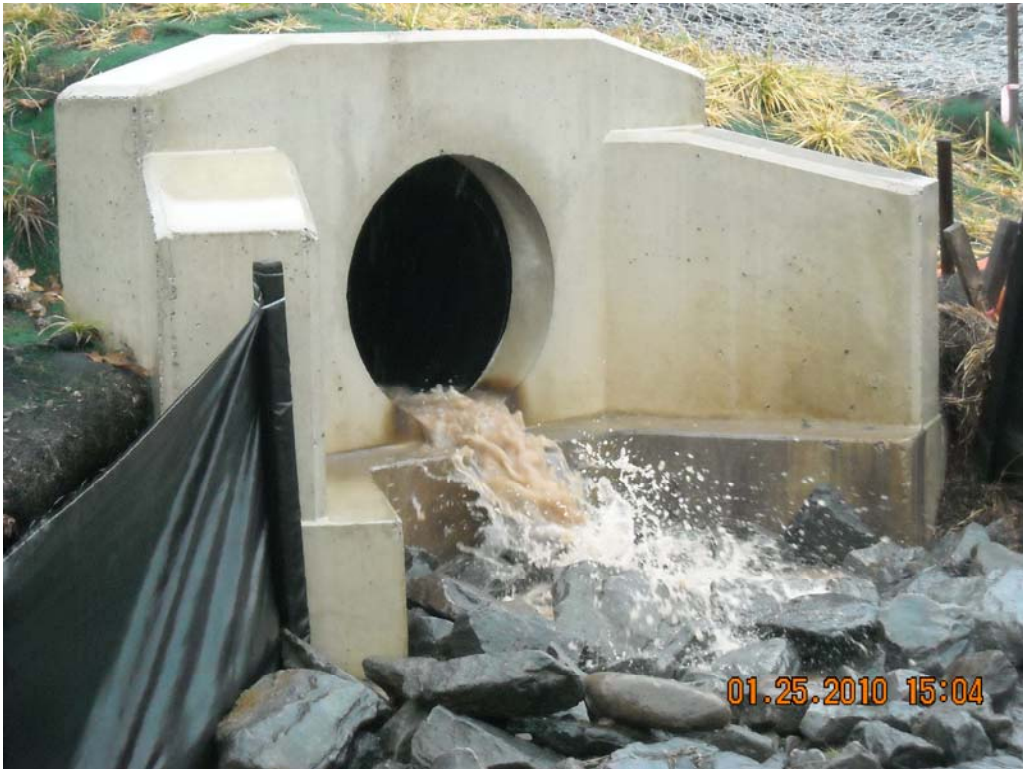
During a rain event on January 25, 2010, an erosion and sediment control (E&S) inspection was performed at the Marjol site by Advanced GeoServices and SCE. At approximately 1445 Advanced GeoServices performed a daily discharge turbidity reading at the discharge point (perimeter fence at the sediment basin discharge channel) and observed a turbidity reading of 1,785 NTUs, which is in excess of the 250 NTU performance standard. Based on this reading, Advanced GeoServices and SCE reviewed the outlet structure and skimmer in the basin and observed that the skimmer head had separated from the skimmer arm. The skimmer arm had submerged below the surface and was discharging water from the lower portions of the basin. SCE raised the skimmer arm to prevent further discharge from the basin. The level of water within the basin at this time was approximately 3 feet above the skimmer orifice. Attached are pictures of the discharge, Sulphur Creek and Lackawanna River during the time of the event.

Basin discharge into discharge channel 01-25-10

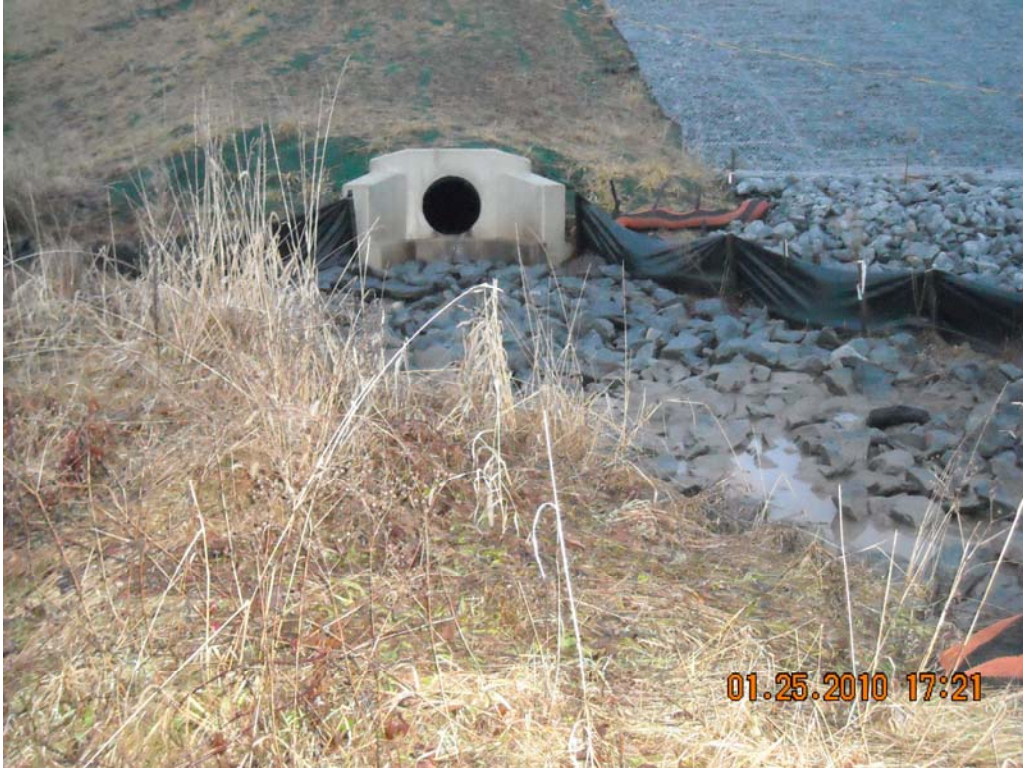
Basin discharge channel 01-25-10
