RE: Sediment Basin Discharge Report
NPDES Permit No. PAI023508001
Marjol Battery Site, Throop, Pennsylvania

Advanced GeoServices, on behalf of Gould Electronics Inc. (Gould), submits the enclosed report for stormwater discharge activities that occurred between Thursday, September 30, 2010 and Saturday, October 16, 2010 at the Marjol Battery Site (Site) in Throop, Pennsylvania. Corrective Measures at the Site are being conducted as required by the Final Administrative Order on Consent between U.S. Environmental Protection Agency (USEPA), Pennsylvania Department of Environmental Protection (PADEP) and Gould. Work activities are conducted in accordance with the Final (100%) Remedial Design approved by USEPA and PADEP on June 9, 2008 and NPDES Permit No. PAI023508001. Construction activities at the Site were concluded on August 27, 2010 and the Site is in the post-construction period. Tab 5 of the Sampling and Analysis Plan in the approved Final (100%) Design covers the basin discharge monitoring requirements which state that discharge monitoring will not occur post-construction. Gould has voluntarily continued sampling the basin discharge so far during the post-construction period, a

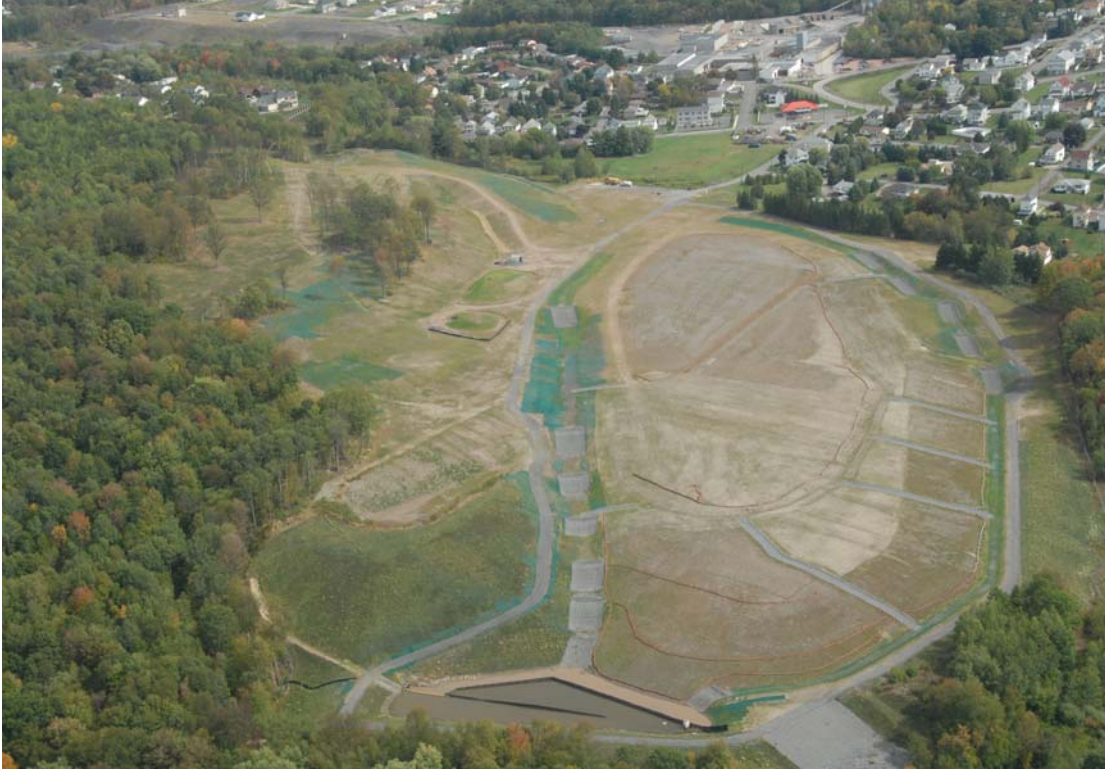
Prior to the discharges discussed below, rain events occurred on September 27 and 28, 2010. The total combined rainfall for both days was approximately 0.32 inches. Discharge from the basin began on September 29, and the turbidity reading was 3.91 NTUs. The attached aerial photo shows the turbid water contained on the east side of the baffle while the west side, where the skimmer discharges the water, is clear.

Aerial View of Site on September 28, 2010

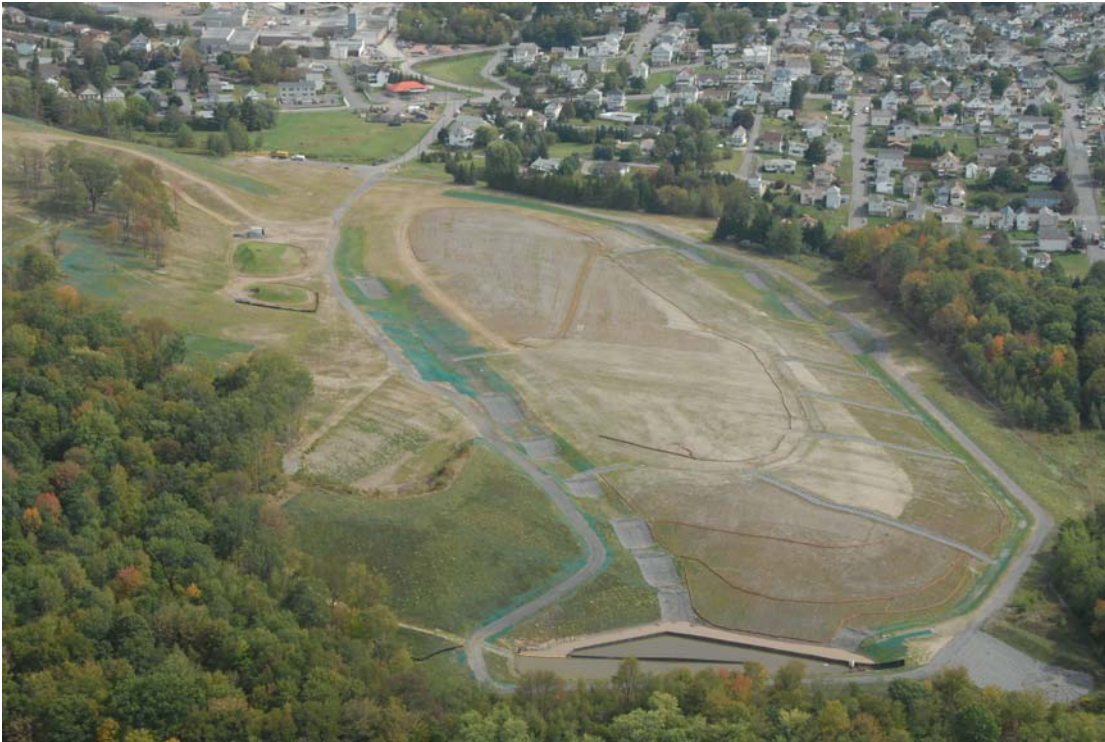
Aerial View of Site on September 28, 2010

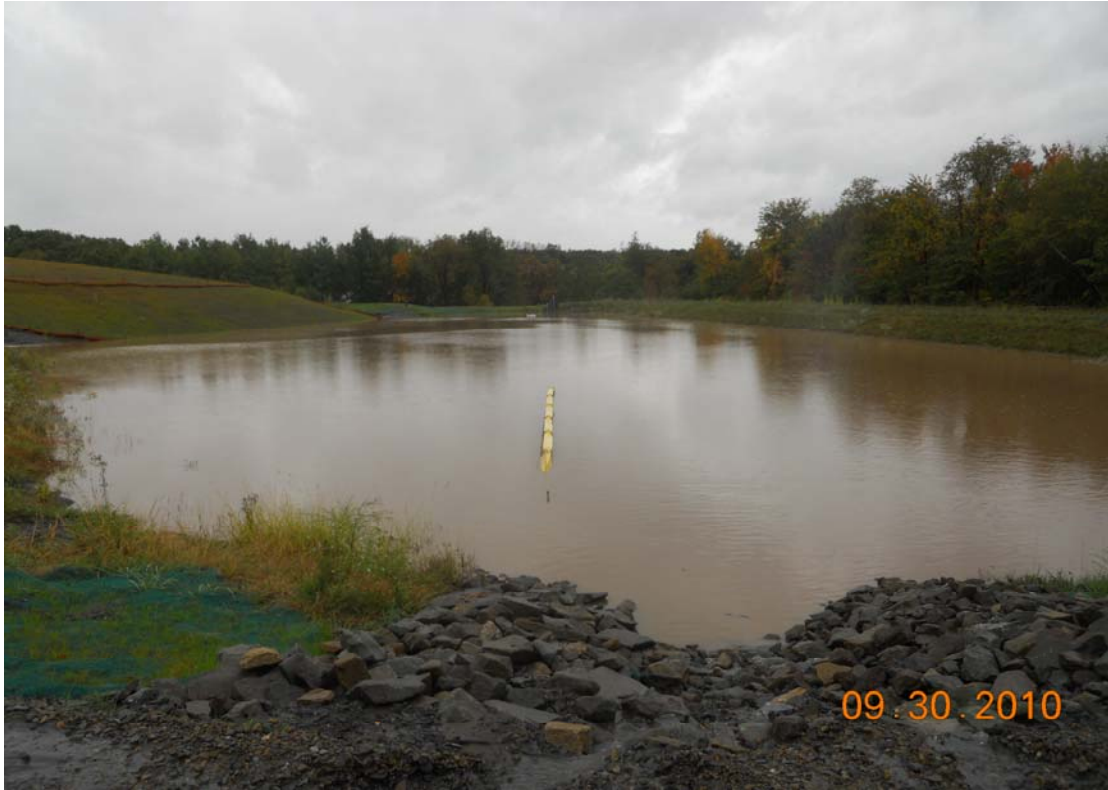
On September 30 at 0745, Advanced GeoServices collected a turbidity sample at the discharge point of the stormwater basin which is located at the perimeter fence line of the discharge channel. The result of the sampling was 67.1 NTUs. At 1350, Advanced GeoServices collected another turbidity sample at the discharge point. The result was 2,446 NTUs. Water samples were collected for total and dissolved lead analysis. The results of the sampling are provided in the table below. As the water level in the basin continued to rise and overtopped the outlet structure, the discharge was allowed to continue to prevent the basin from overtopping the emergency spillway. Considering the significant flow into the basin and continued heavy rains, it also was not feasible to add flocculant during this time. Photos are attached showing the water level in the basin.

View of Sediment Basin on September 30, 2010 (toward Sulphur Creek)

As no additional rain events were forecasted for the weekend, Advanced GeoServices requested that SCE rotate the skimmer to discontinue discharge and apply Pond Clear to the basin to help settle out the sediment over the weekend. SCE reported to the site, discontinued the discharge and added 800 pounds of flocculant. SCE also removed the organic debris that had accumulated over the outlet structure grate.

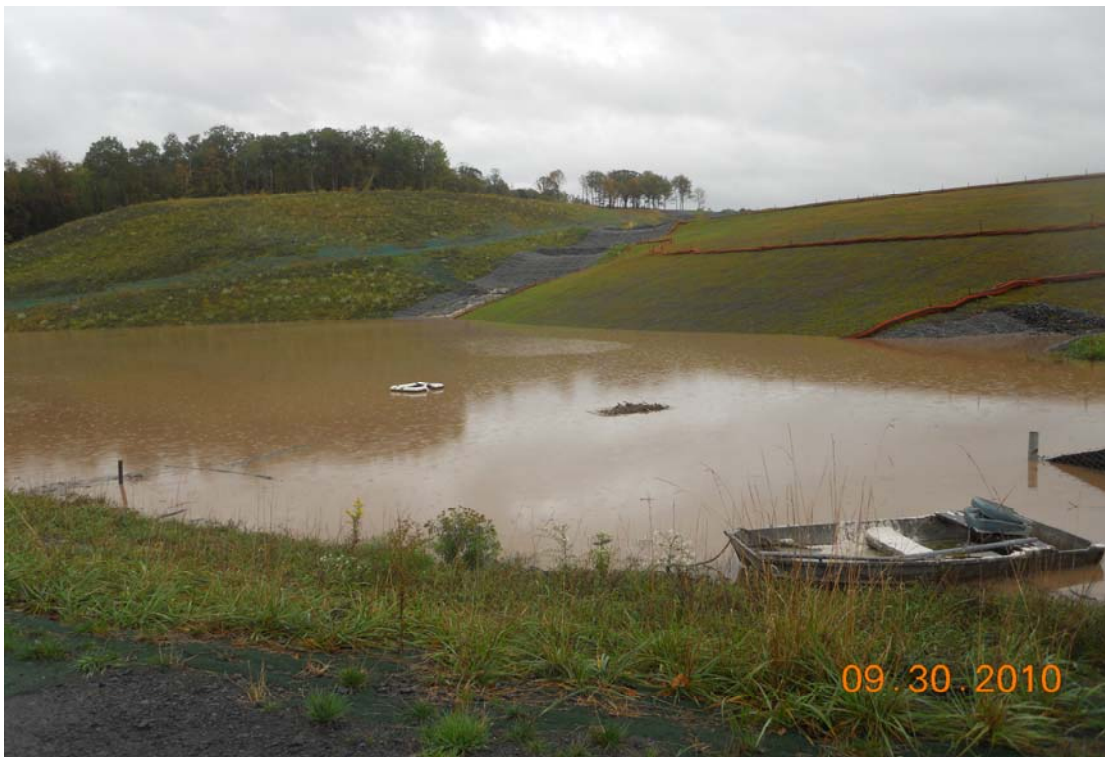
View of Sediment Basin on September 30, 2010 (facing northeast)
