Marjol Site Remediation Update

Number 95

November 23, 2009

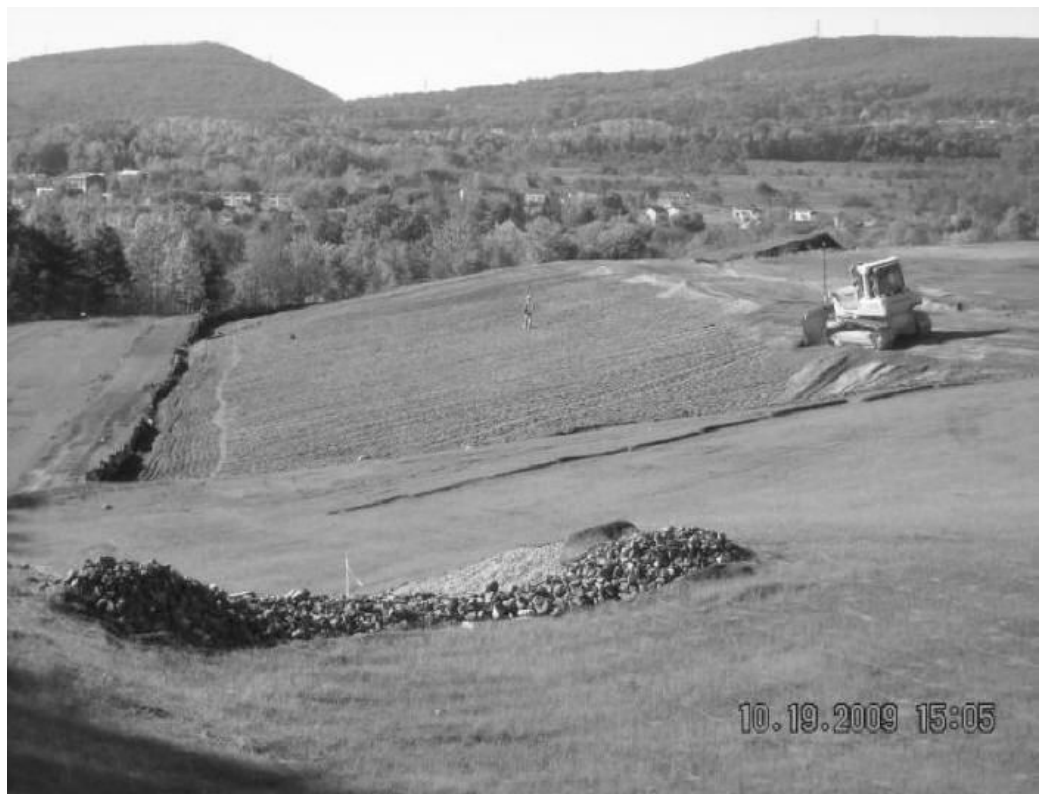
View of 4:1 Slope During Solidification Activities—10/19/09

Construction of the Final Remedy at the Marjol Battery Site is continuing through the final stages with several notable milestones having recently been reached. Excavation of contaminated fill material has been completed; the contaminated material was placed in the Containment (Cap) Area (CA) and covered with imported, clean (i.e., background levels of lead and other possible contaminants) solidified fill material for protection. With all of the excavated contaminated fill material at the Site having been placed in the CA and the CA having a layer of clean solidified fill material on top of it, this means that none of the surfaces at the site have lead levels above the USEPA/PADEP Final Remedy clean-up standard. Some sediments with lead levels above the clean-up standard remain covered by water in the sedimentation basin. These sediments will be removed when the weather is dry enough. The sediments will be solidified, placed in the Containment Area, and covered with either a clean solidified fill layer or plastic over the winter. In the spring, the sediments will be spread and compacted just before the geosynthetic layers of the cap are installed.

This solidified material forms the bottom layer of the cap (see cap cross section on Page 3) and is about 24 to 27 inches thick. Off-site sources of clean fill were used for solidification of the third lift across the entire CA because there was an insufficient volume of contaminated soil in the last excavation area for the entire thickness of this bottom layer of the cap. Having the top solidified lift created with clean fill also provides greater protection for the contaminated materials over the winter as well as in the extremely unlikely event of erosion of the cover soils and a tear in the geosynthetics in the future.

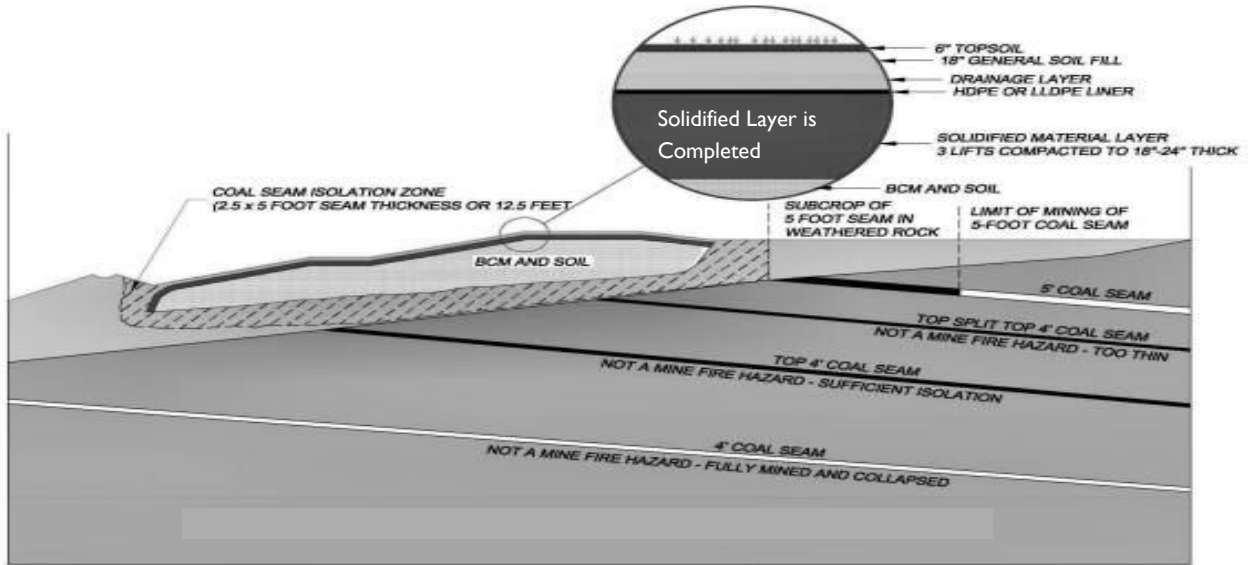
GENERALIZED CROSS-SECTION WITH CONCEPTUAL REMEDY

Note: BCM = Battery Casing Material HDPE = high density polyethylene LLDPE= linear low density polyethylene

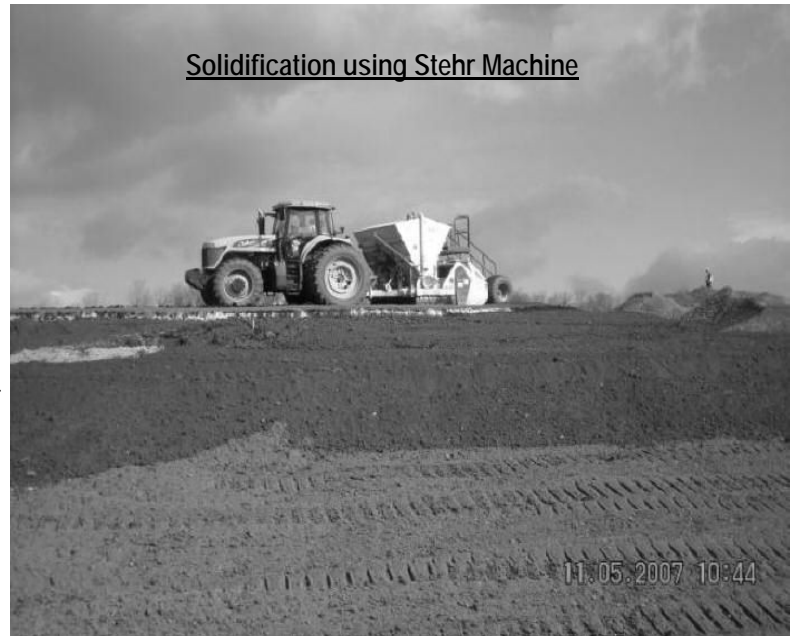
Solidification using Stehr Machine
